Detailed Records of Stream Mapping Turf EIA

Stream Mapping Point No.	Cross-section No.	Longitude	Latitude	Photo (In the order of: Upstream, Stream Bed and Downstream)	Photos of Cross-Section	Cross-section	Channel Wetted Width	Water Depth	Flow Velocity (Dry Weather)	Bed Substrate and Bank Conditions	Riparian Vegetation	Leaf Litter Cover (%)	Canopy Cover (%)	Soil Erosion	Remarks
CW1	-	103.79089	1.34509			Cross-section was not mapped due to its dry condition at the upstream.	Not Applicable	Not Applicable	Not Applicable	Concrete fragments and rocks. Dry earth drain.	Caryota mitis, Fabaceae seedling, Syzygium grande, Caladium sp., Spathodea campanulata, Leea indica, Nephelium lappaceum	5-10%	34.7	No	The starting point of the watercourse within Site E.
CW2	CS12	103.79092	1.34492				0.2 - 0.5 m	5 - 6 cm	Nearly stagnant	Sandy bed, with dead leaves and broken concrete. Earth drain with mild slope, and covered with vegetation.	Acrostichum speciosum, Eleais guineensis, Syzygium grande, Cinnamomum iners, Smilax setosa, Hemigraphis repens, Alsophila laterosa, Ficus heteropleura	50-60%	84.3	Yes	Presence of oil sheen observed. Cloudy brown organic matter observed in the water.

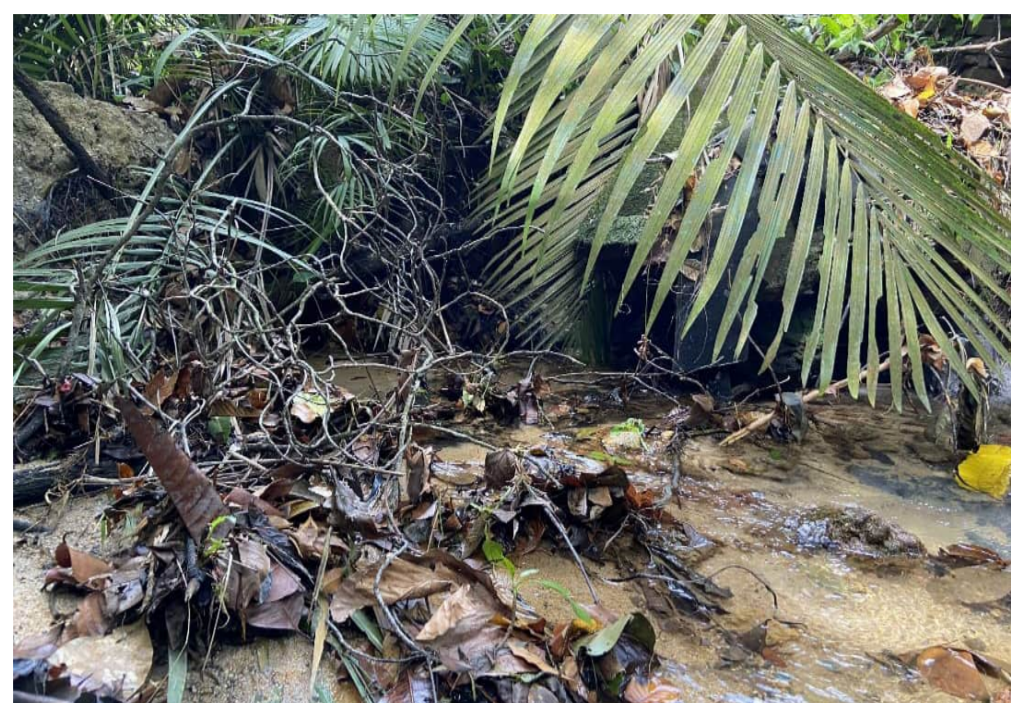
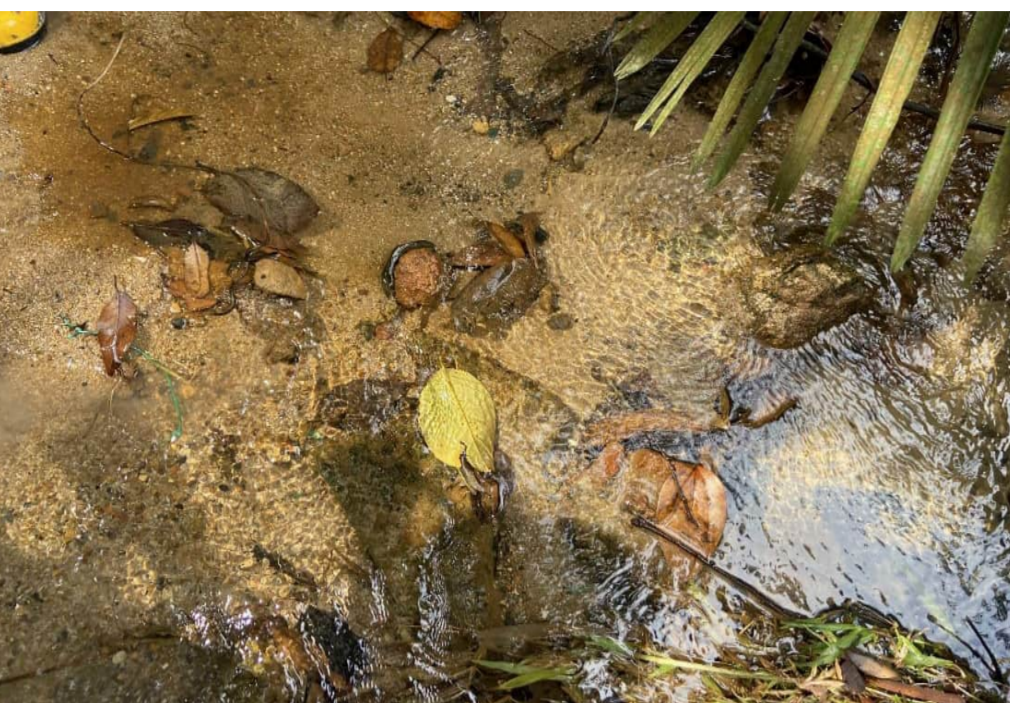
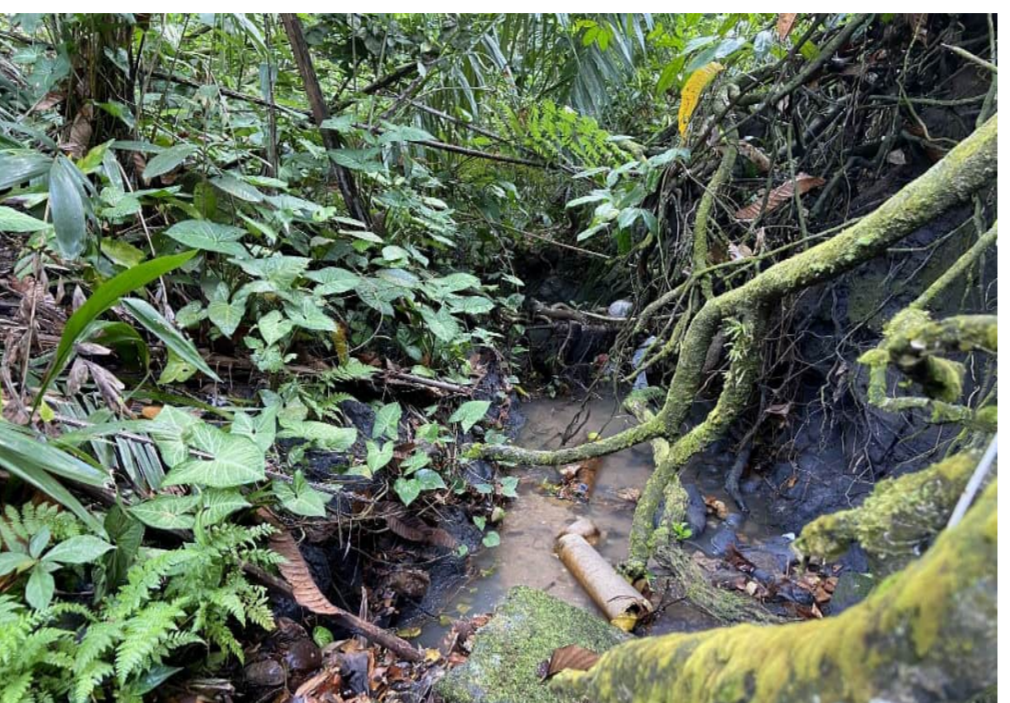
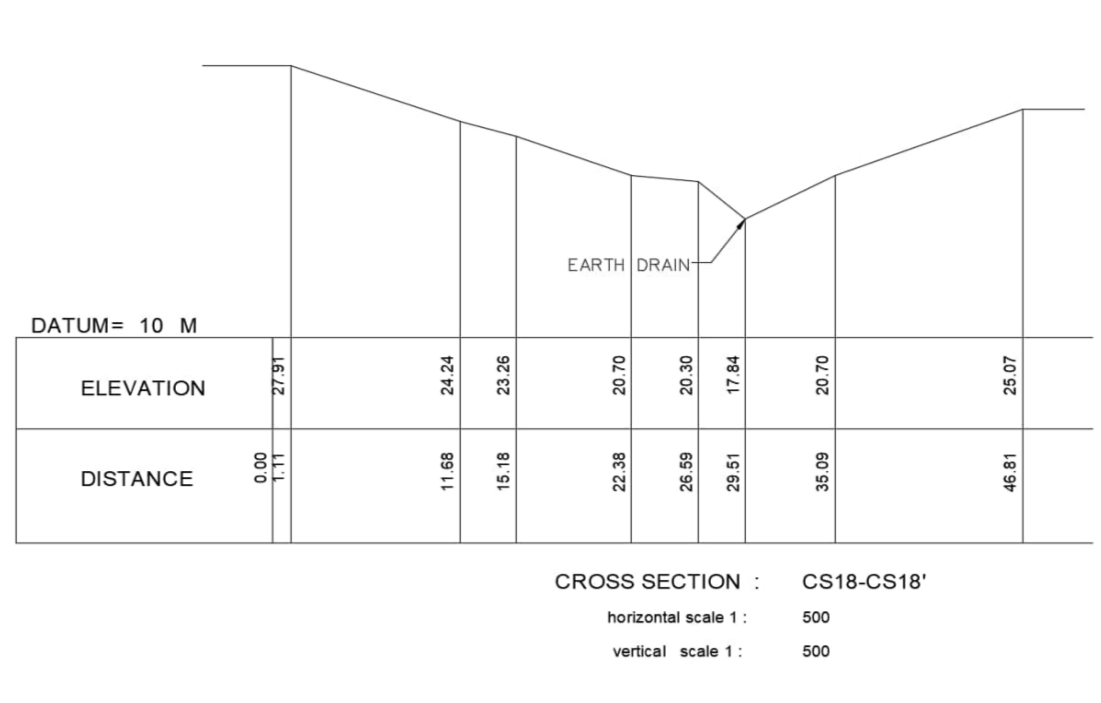
Stream Mapping Point No.	Cross-section No.	Longitude	Latitude	Photo (In the order of: Upstream, Stream Bed and Downstream)	Photos of Cross-Section	Cross-section	Channel Wetted Width	Water Depth	Flow Velocity (Dry Weather)	Bed Substrate and Bank Conditions	Riparian Vegetation	Leaf Litter Cover (%)	Canopy Cover (%)	Soil Erosion	Remarks	
CW7	CS18	103.79147	1.34415

1 - 2 m	10 - 15 cm	0.2 m/s	Sandy bed, with presence of dead leaves and broken concrete slab pieces. Dark grey clay earth banks with very steep/nearly-vertical slope that is covered with tree roots.	Piper betle, Ficus heteropleura, Syzygium grande, Alsophila latebrosa, Syngonium podophyllum, Eleais guineensis, Ficus fistulosa, Caryota mitis, cf. Asplenium nidus	20-25%	8.5	No	
CW8	CS18	103.79169	1.34396

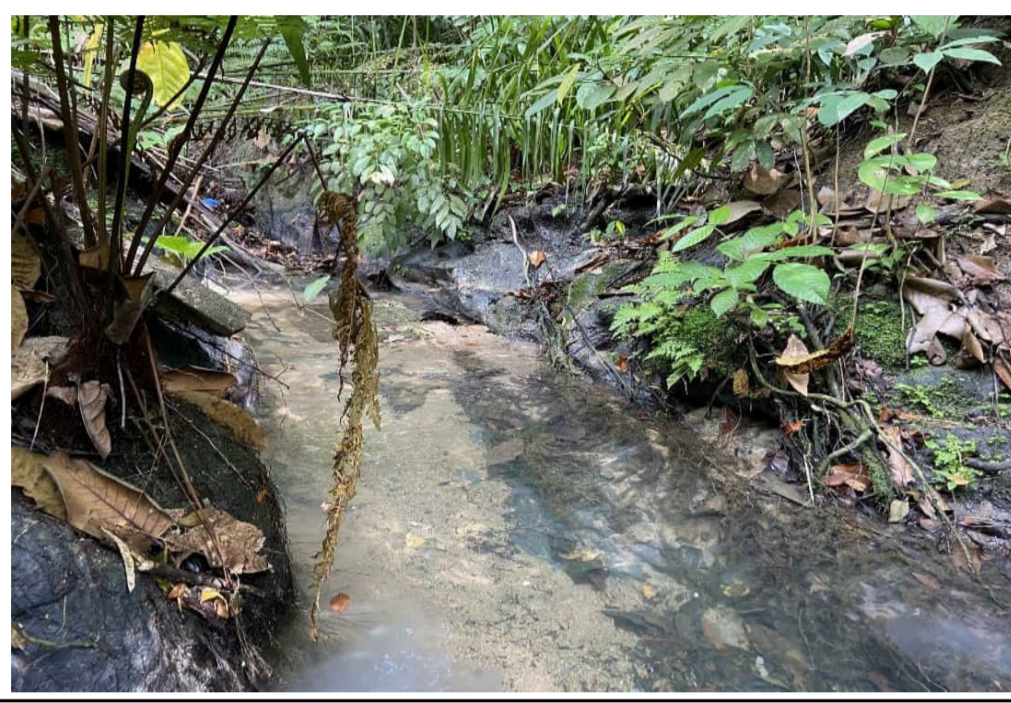
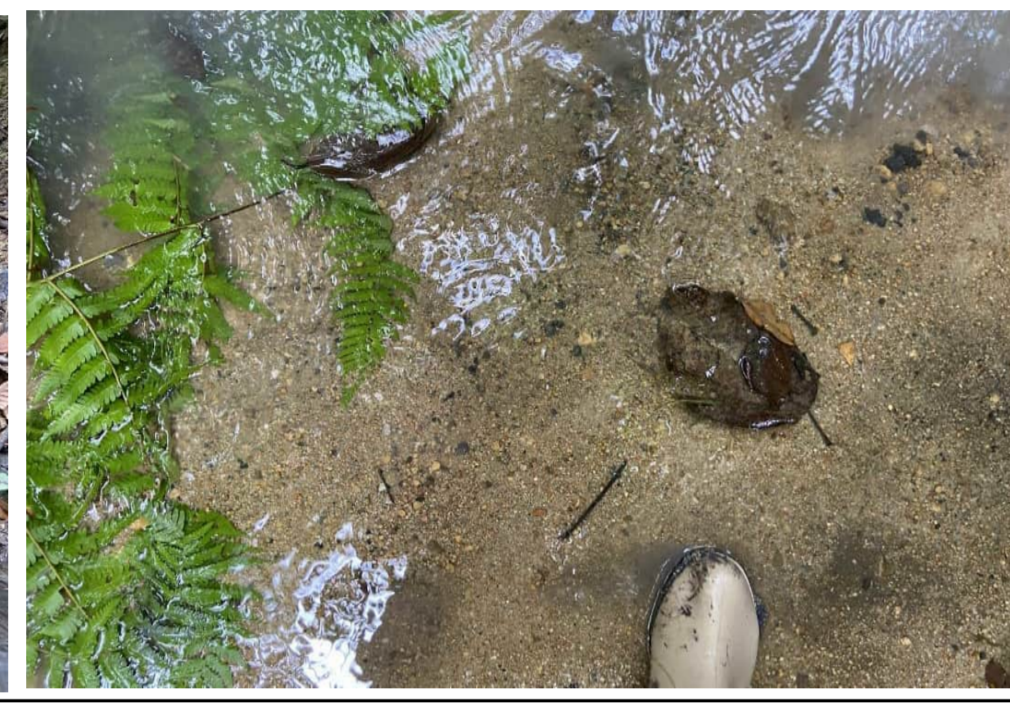
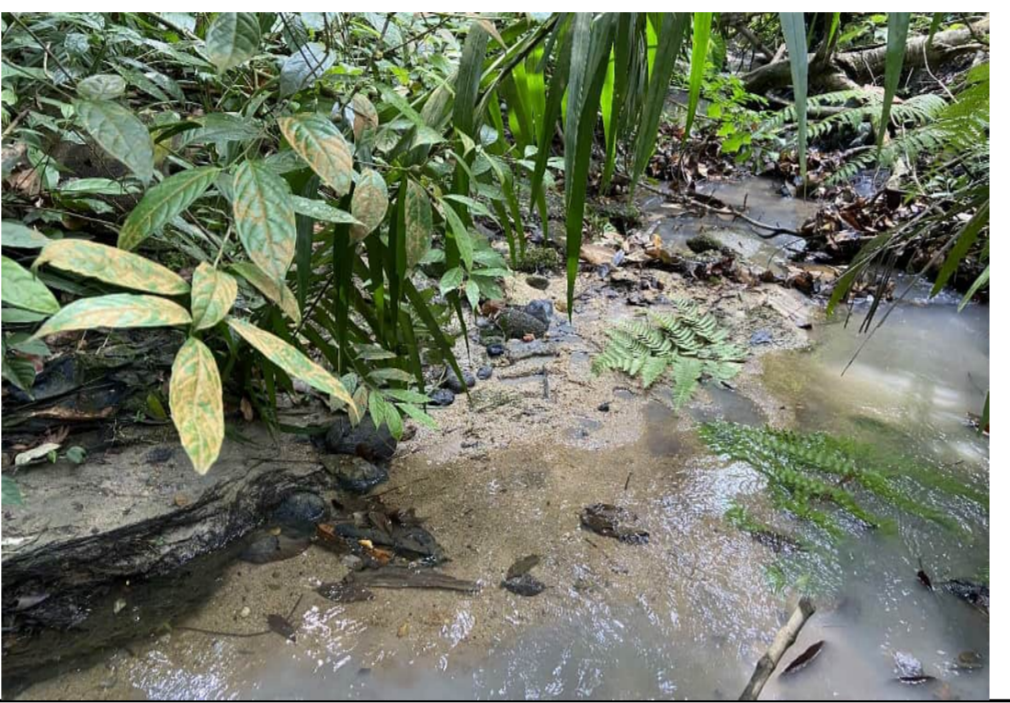
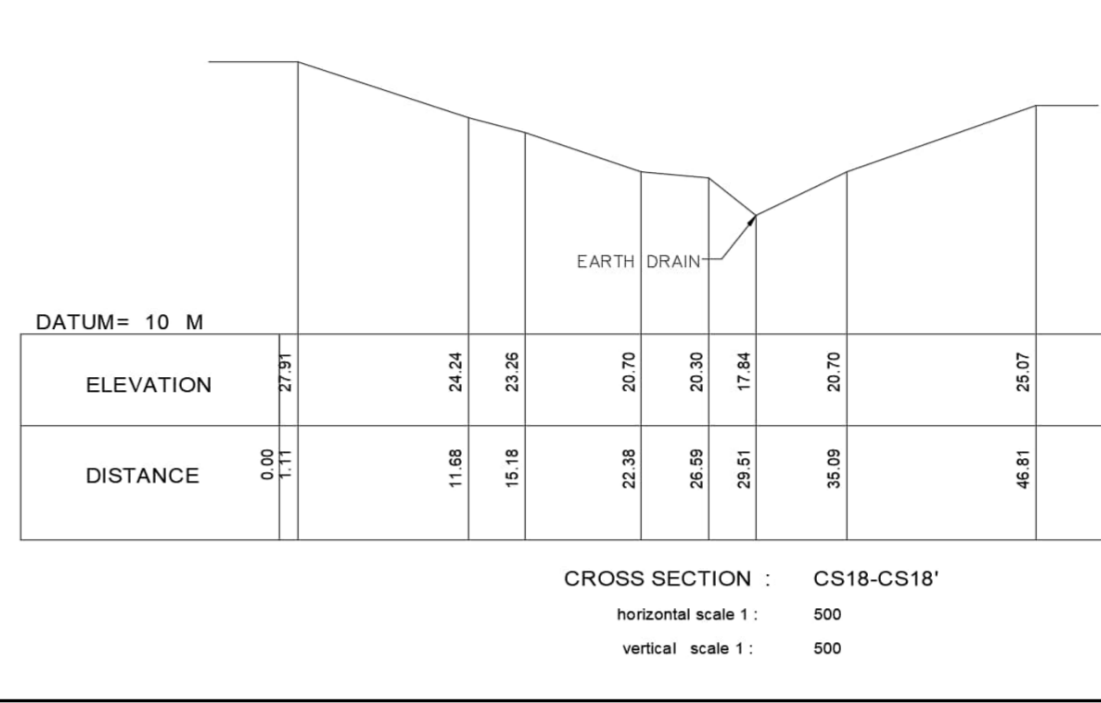
1 - 1.5 m	15 - 20 cm	0.01 m/s	Sandy bed. Dark grey clay earth banks, with steep slopes and covered with dense vegetation.	Aporosa frutescens, Eleais guineensis, Alsophila latebrosa, cf. Fibraurea tinctoria, Ficus fistulosa	10-15%	14.5	Yes

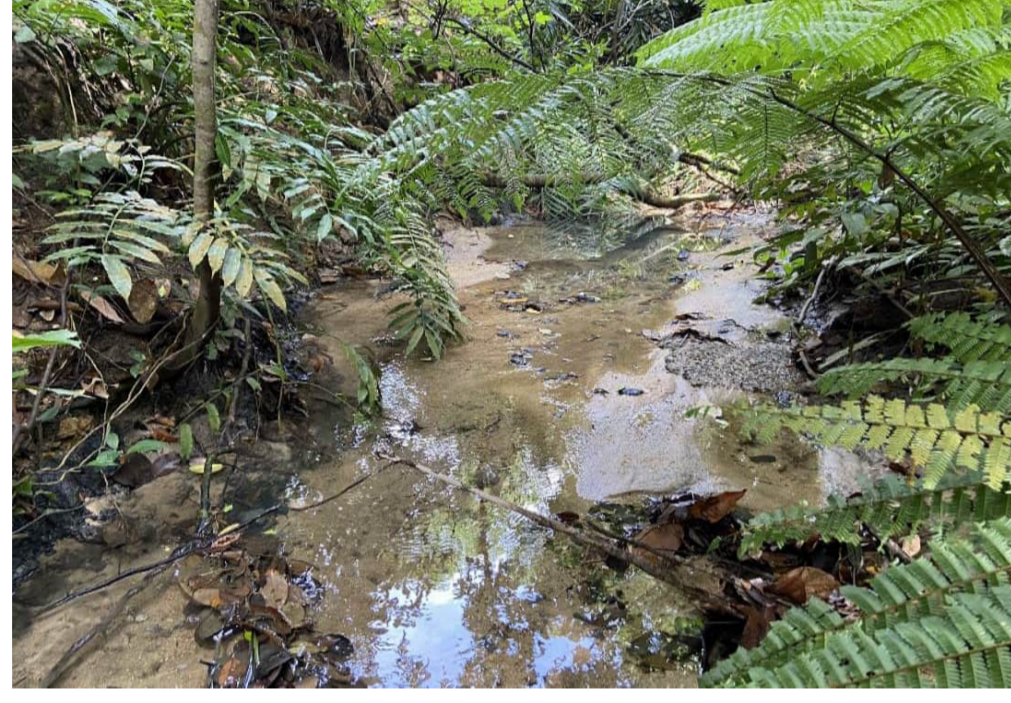
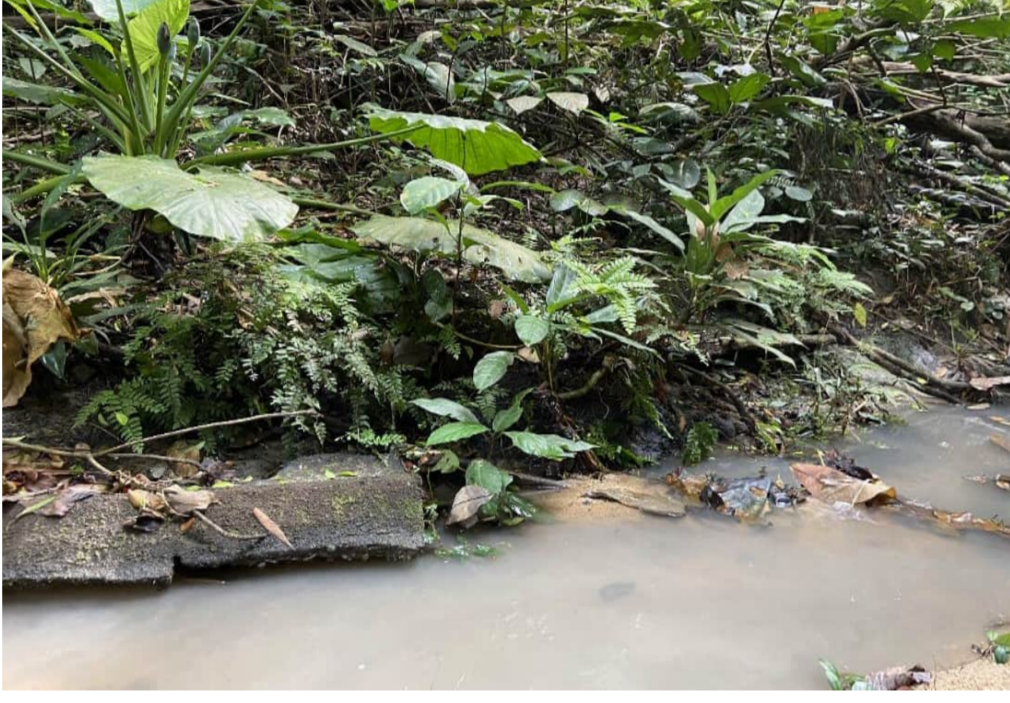
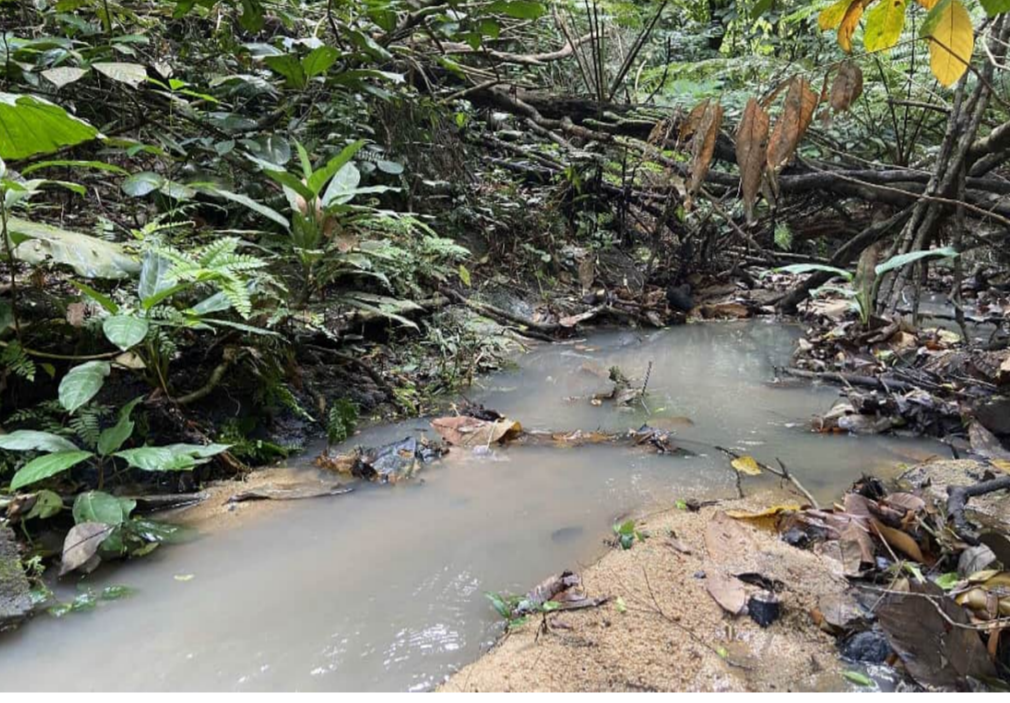
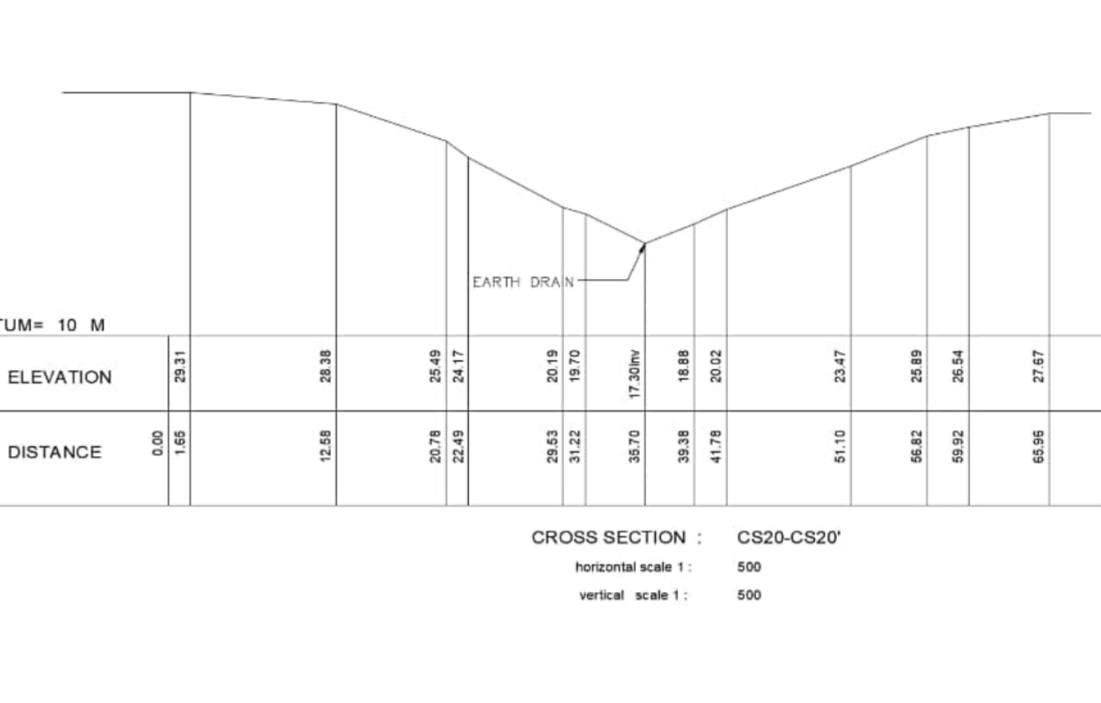
CW9	CS20	103.79176	1.34372

1.2 - 2 m	5 - 12 cm	0.01 m/s	Sandy bed, with broken concrete slab. Earth banks with steep slope, covered with dense vegetation.	Adiantum latifolium, Aglaionema confertum, Alsophila latebrosa, cf. Nephelium lappaceum, Alcasia macrorrhizos, Leea indica, cf. Amphineuron opulentum, Caryota mitis, Claoxylon indicum, Baccaurea motleyana, Claoxylon indicum, Ficus sp, Nephelium lappaceum, Stenochlaena palustris, Hevea brasiliensis, Eleais guineensis	5-10%	78.6	No	
CW10	CS21	103.79184	1.34359

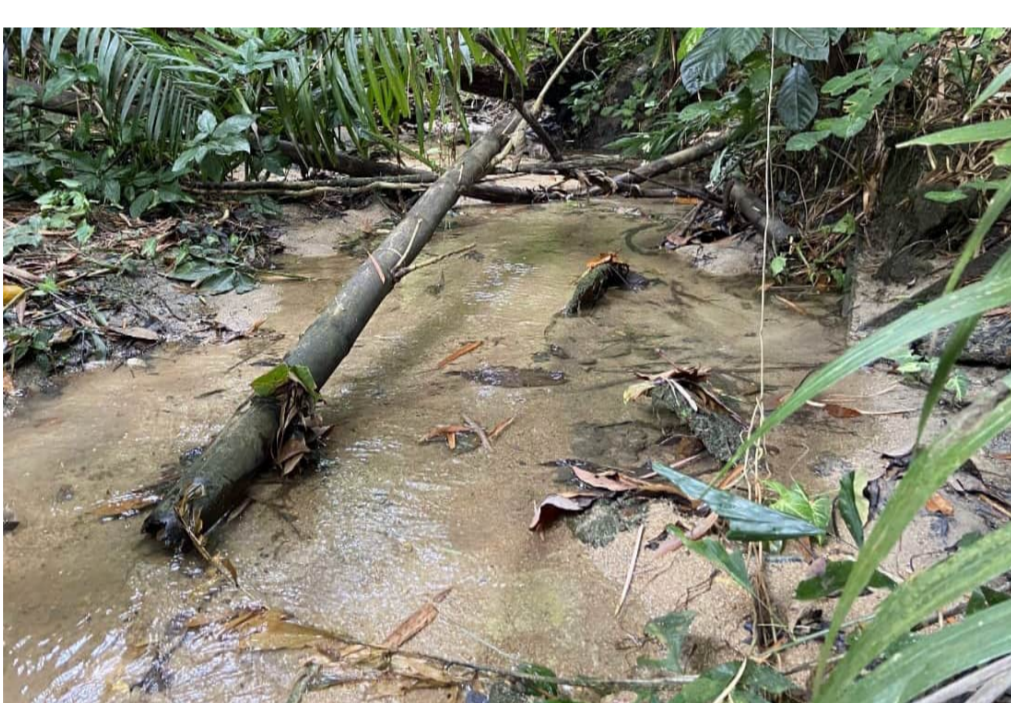
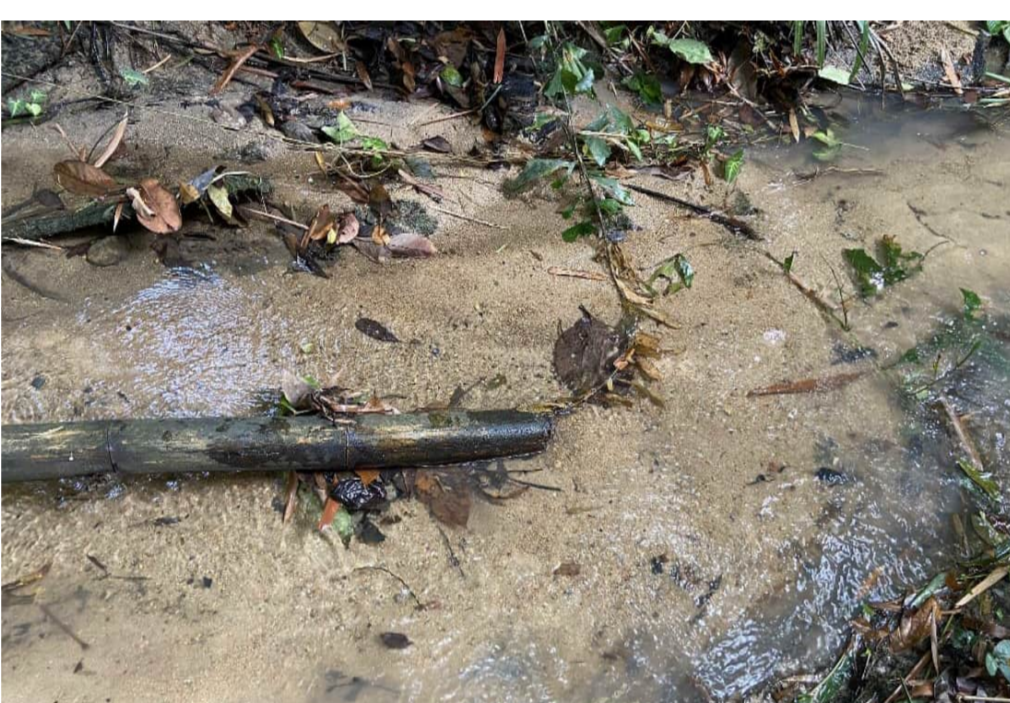
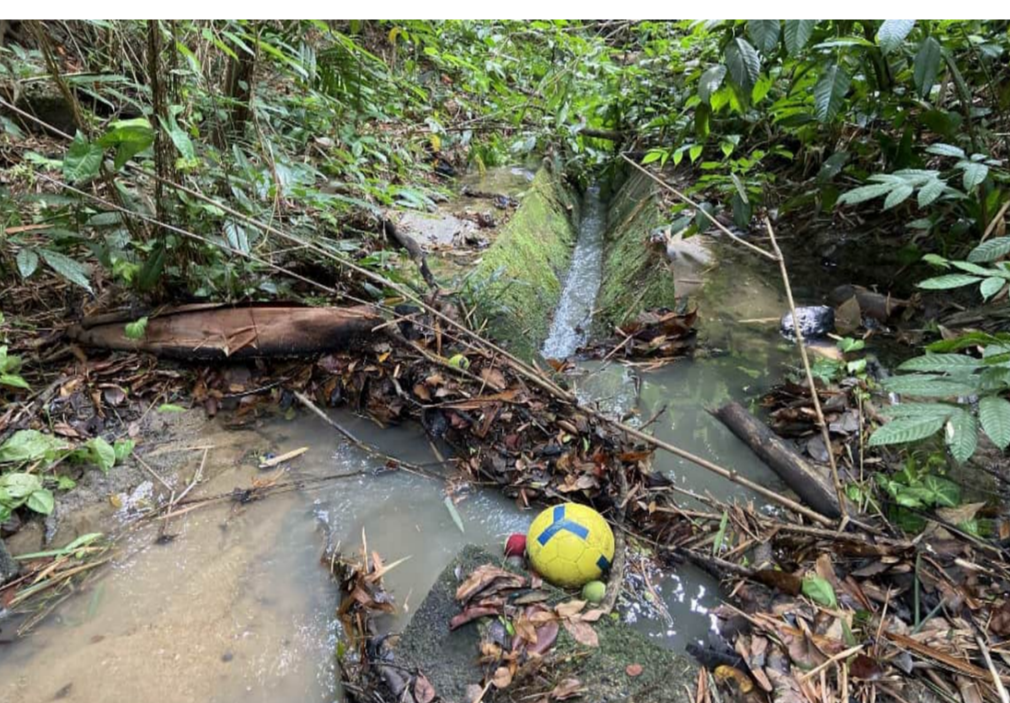
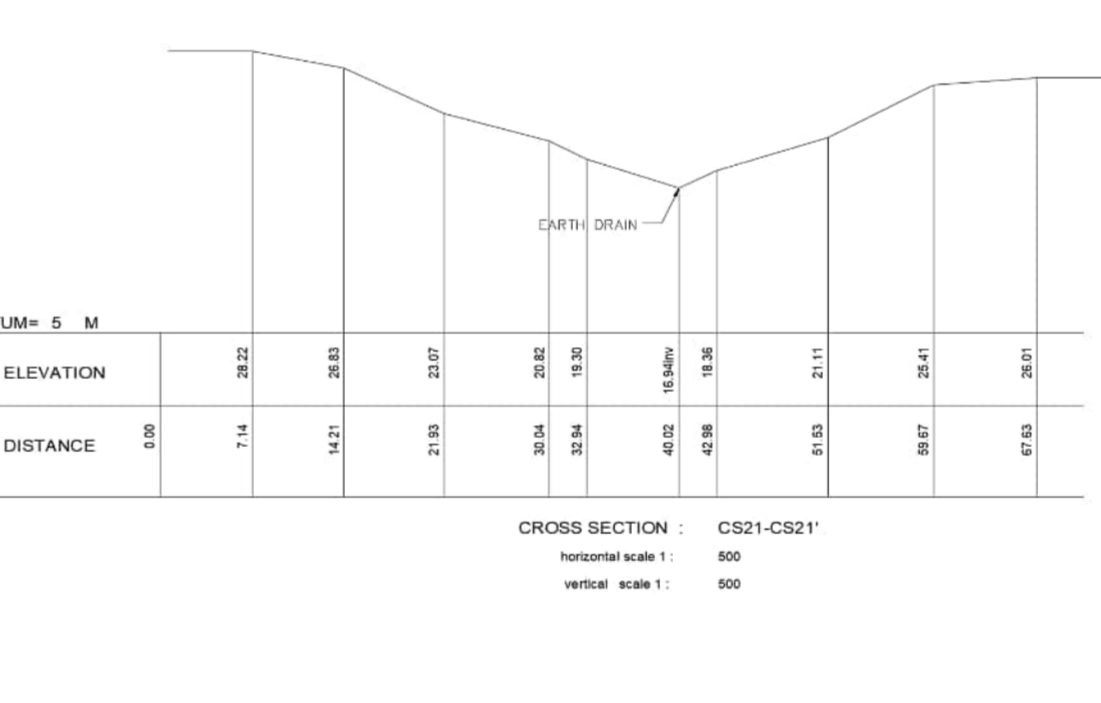
1.25 - 1.9 m	9 - 22 cm	0.2 m/s	Sandy bed, with broken concrete slabs and dead leaves. Downstream photo shows a waterlogged area filled with dead leaves, before transiting to a concrete drain. Earth banks with mild slopes, covered with dense vegetation.	Leea indica, Eleais guineensis, Caladium sp., cf. Ficus heteropleura, Caryota mitis, Alsophila latebrosa, Adiantum latifolium	0-5%	65.3	Yes

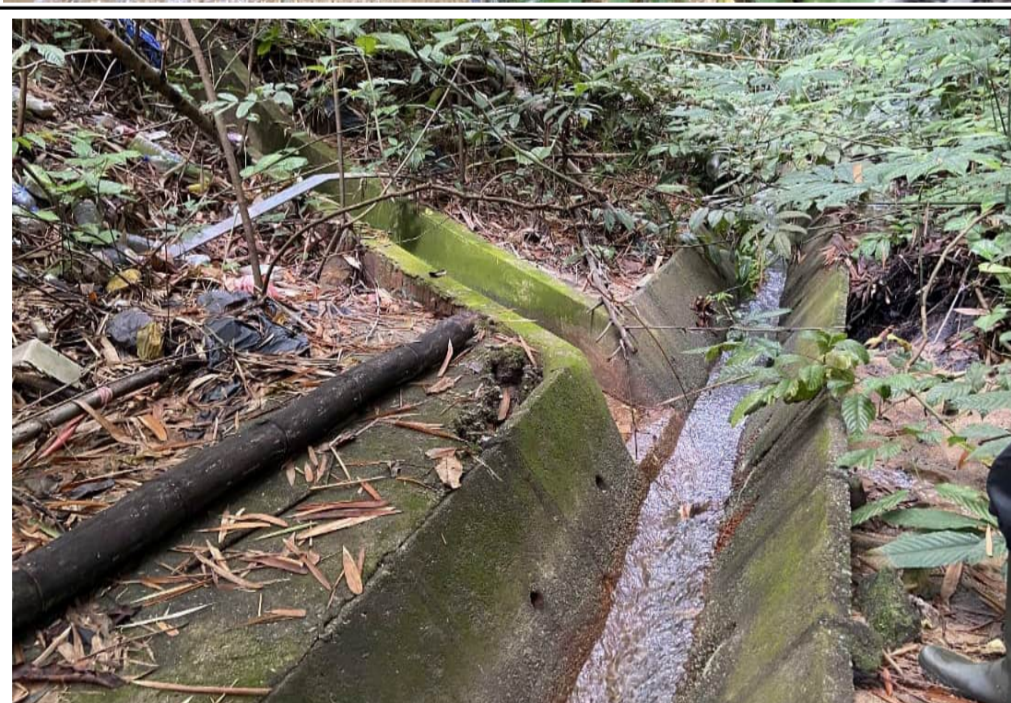
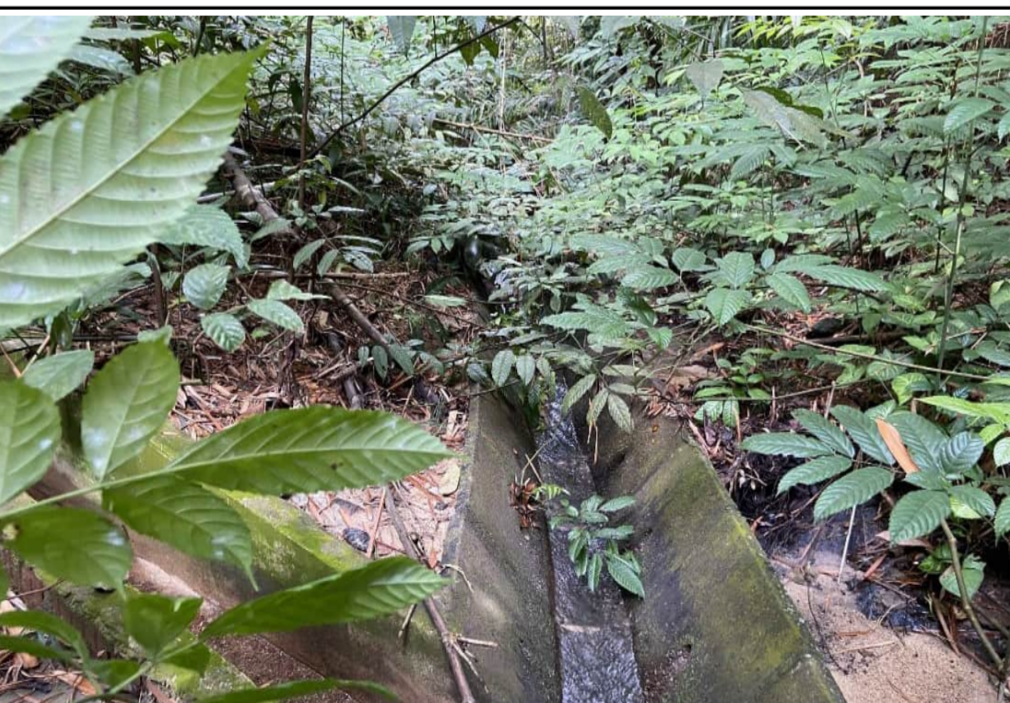
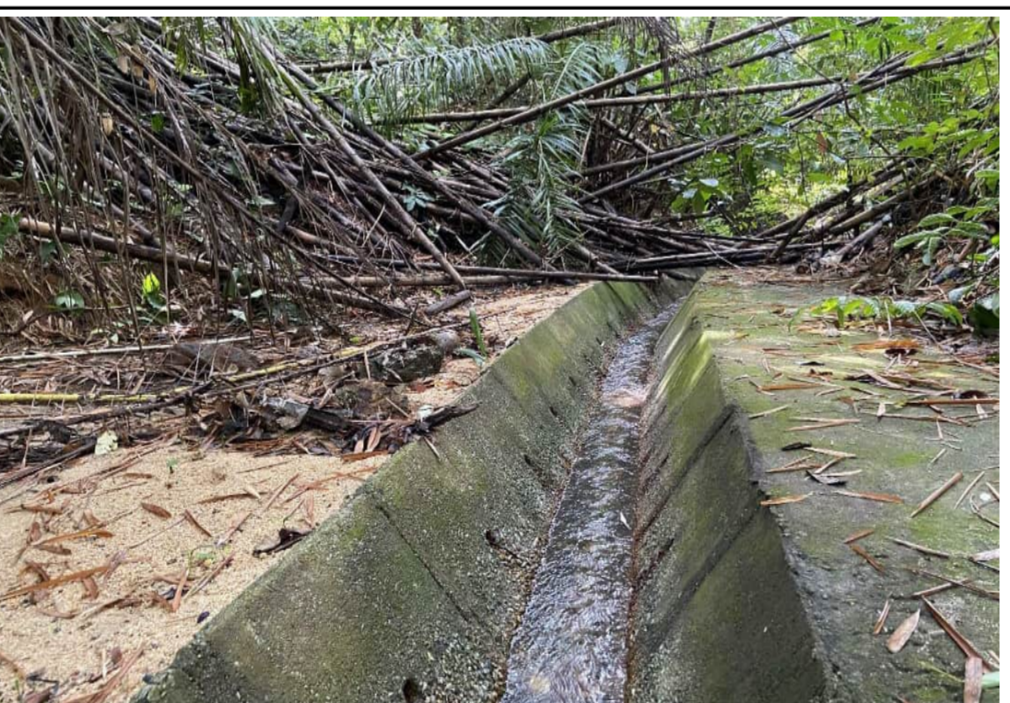
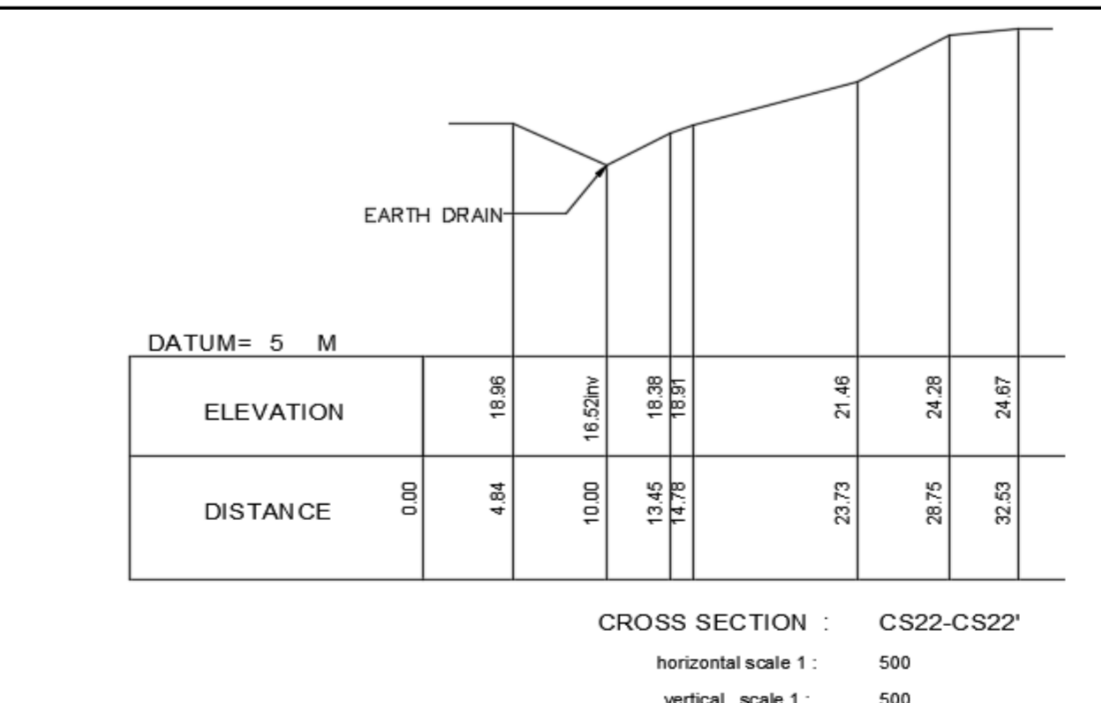
CW11	CS22	103.79191	1.34337

0.1 - 0.2 m	5 - 10 cm	0.4 m/s	Man-made concrete drain. Earth banks with mild slopes, covered with dense vegetation.	Eleais guineensis, Leea indica, Hevea brasiliensis, Caladium sp., Elaeocharis petiolatus, cf. Nephelium lappaceum	0%	63.6	No	Adjacent to an outlet located within the vegetation, which discharges a small flow which feeds into the drain.
CW12	CS23	103.79194	1.34329

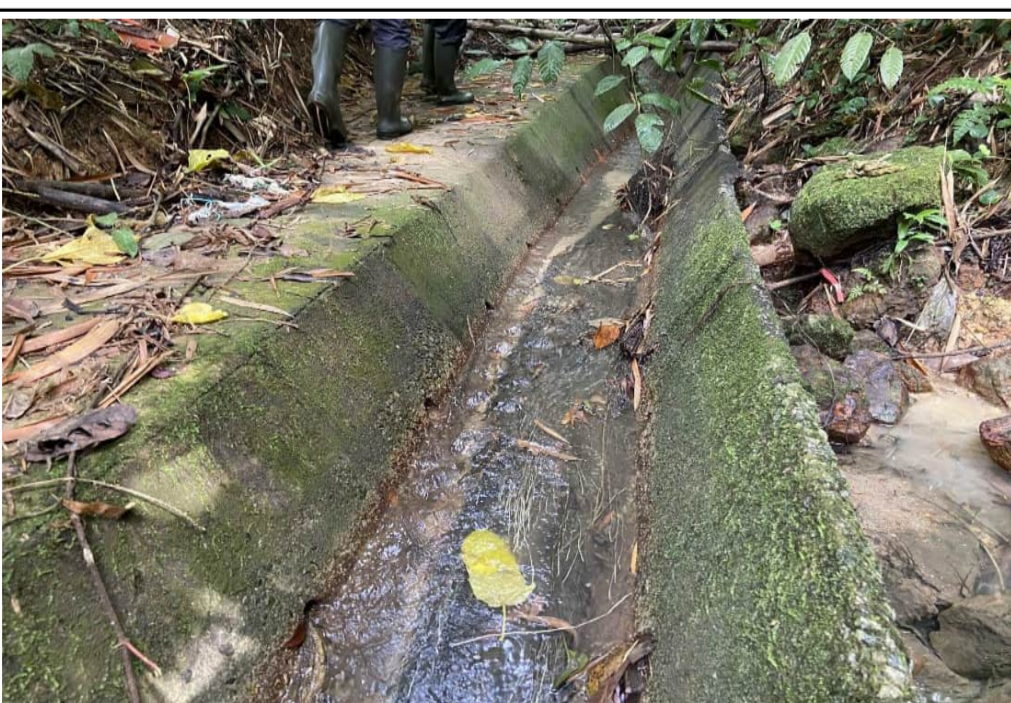
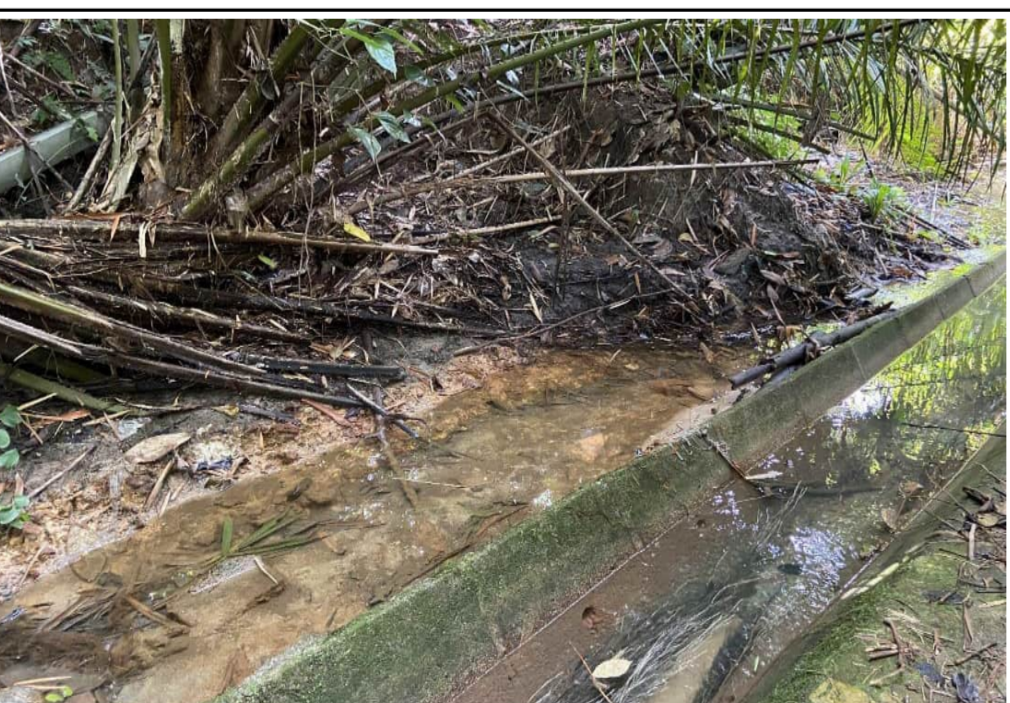
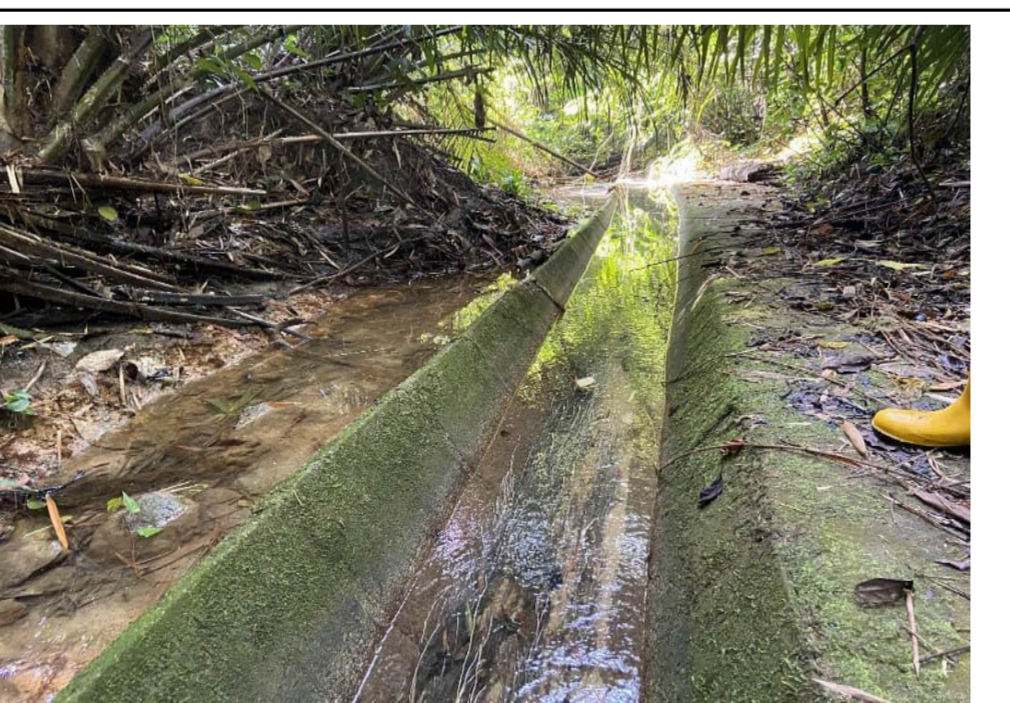
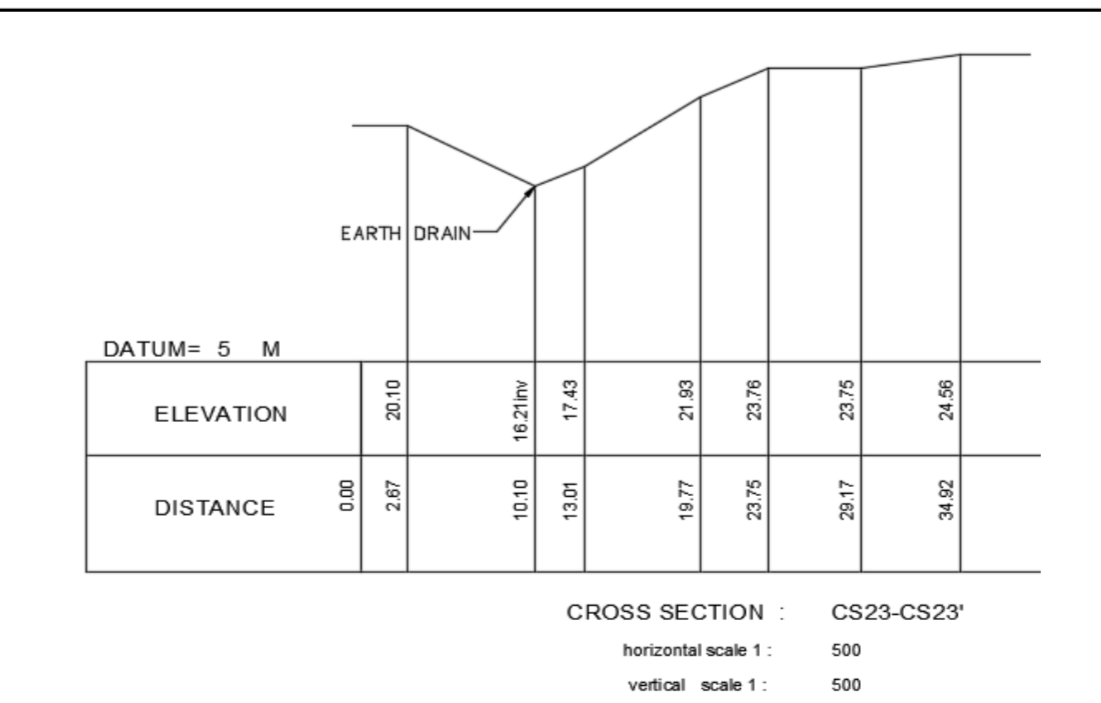
0.3 - 0.35 m	15 - 20 cm	0.3 m/s	Man-made concrete drain with sand and dead leaves. Earth banks with mild slope, covered by dense vegetation.	Eleais guineensis, Leea indica	0-5%	61.1	No	Adjacent to a waterlogged area.

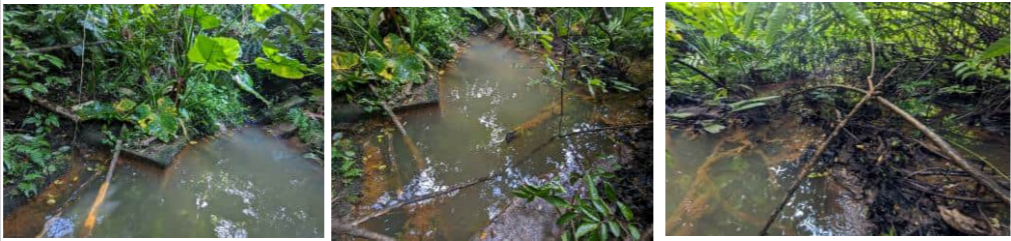
Stream Mapping Point	Cross-section No.	Longitude	Latitude	Photo (In the order of: Upstream, Stream Bed and Downstream)	Channel Wetted Width (m)	Water Depth (cm)	Flow Velocity (Dry Weather) (m/s)	Bed Substrate and Bank Conditions	Riparian Vegetation	Leaf Litter Cover (%)	Canopy Cover (%)	Soil Erosion	Remarks
BW1	CS1 (Drawing 1)	103°47'50.183"E	1°20'22.831"N

2.13 at discharge of concrete portion. Widens downstream.	112	0.063	Concrete bed and banks, towards mouth it is vegetated flooding area.	<i>Artocarpus heterophyllus</i> <i>Cinnamomum iners</i> <i>Acalypha siamensis</i> <i>Alocasia macrorrhizos</i> <i>Amblovenatum opulentum</i> <i>Callisia repens</i> <i>Caryota mitis</i> <i>Christella dentata</i> <i>Claoxylon indicum</i> <i>Dieffenbachia seguine var. seguine</i> <i>Epipremnum aureum</i> <i>Ficus fistulosa</i> <i>Ficus punctata</i> <i>Leea indica</i> <i>Musa cultivar</i> <i>Nephelium lappaceum</i> <i>Pipturus argenteus</i> <i>Syngonium angustatum</i>	Unable to assess as unable to see bottom.	63.5	No	Fishes inside. Water is slightly murky.

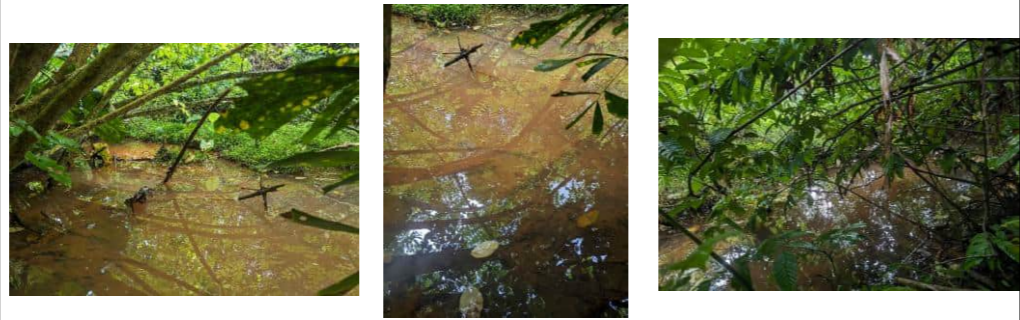
BW2	CS2 (Drawing 1)	103°47'50.152"E	1°20'22.226"N

3.82	30 - 60	Almost stagnant	Clay banks with tall grass on left, vegetated clay banks on right. Clay bed. There are vegetation in stream as well.	<i>Aphanamixis polystachya</i> <i>Alocasia macrorrhizos</i> <i>Alocasia macrorrhizos</i> <i>Alocasia macrorrhizos</i> <i>Callisia repens</i> <i>Caryota mitis</i> <i>Leea indica</i> <i>Miconia crenata</i> <i>Syzygium myrtifolium</i> <i>Ptychosperma macarthurii</i> <i>Spathodea campanulata</i> <i>Syzygium grande</i> <i>Syzygium polyanthum</i>	25	78.4	No	Orangey filaments inside
BW3	CS3 (Drawing 1)	103°47'50.368"E	1°20'21.797"N

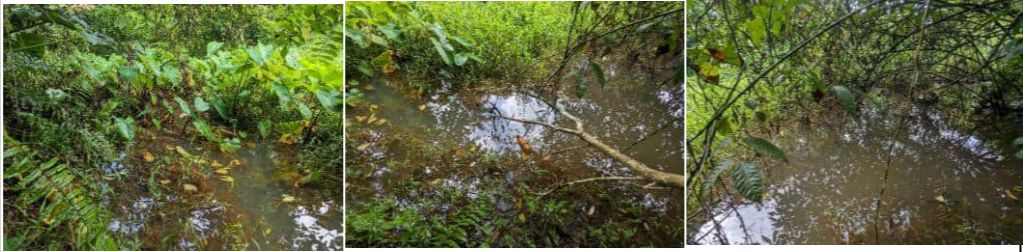
3.50	36 - 56	0.025	Clay banks with tall grass on left, vegetated clay banks on right. Clay bed. There are vegetation in stream as well.	<i>Aphanamixis polystachya</i> <i>Bridelia tomentosa</i> <i>Cinnamomum iners</i> <i>Alocasia macrorrhizos</i> <i>Asystasia gangetica ssp. micrantha</i> <i>Caryota mitis</i> <i>Cenchrus purpureus</i> <i>Colocasia esculenta</i> <i>Isachne globosa</i> <i>Leea indica</i> <i>Miconia crenata</i> <i>Nephrolepis biserrata</i> <i>Stenochlaena palustris</i> <i>Spathodea campanulata</i>	100	48.1	No	Fishes inside. Water is slightly murky.

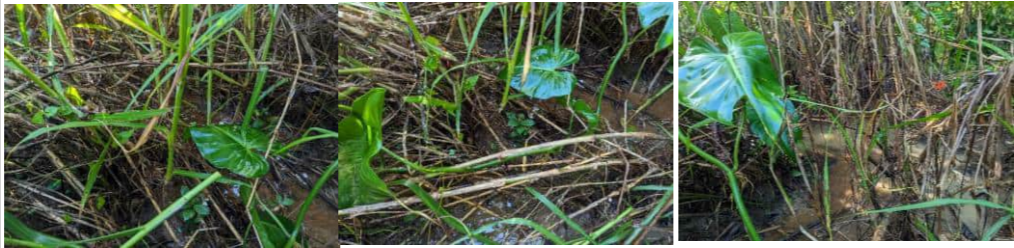
BW4	CS4 (Drawing 1)	103°47'50.424"E	1°20'21.089"N

Not able to see due to dense vegetation surrounding. Area is similar to a flooded grassland.	14	0.160	Vegetated (grass) clay bed and banks, area is covered in roots.	<i>Cenchrus purpureus</i> <i>Leea indica</i> <i>Mikania micrantha</i> <i>Nephrolepis biserrata</i> <i>Philodendron hederaceum</i>	0	0	No	No remarks.

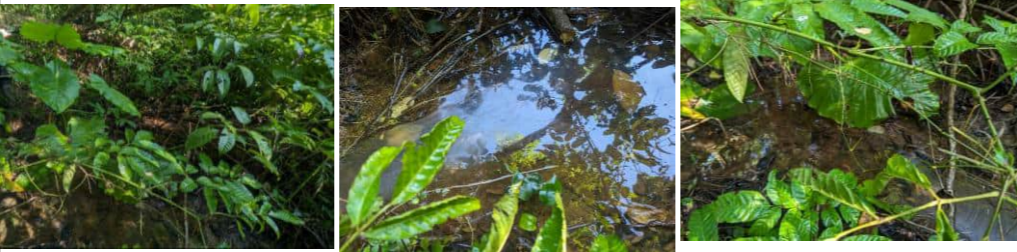
Stream Mapping Point	Cross-section No.	Longitude	Latitude	Photo (In the order of: Upstream, Stream Bed and Downstream)	Channel Wetted Width (m)	Water Depth (cm)	Flow Velocity (Dry Weather) (m/s)	Bed Substrate and Bank Conditions	Riparian Vegetation	Leaf Litter Cover (%)	Canopy Cover (%)	Soil Erosion	Remarks	
BW5	CS5 (Drawing 1)	103°47'50.627"E	1°20'20.544"N

At least 5m wide; not able to see due to dense vegetation surrounding. Area is similar to a flooded grassland.	16	0.071	Clay like banks and bed with vegetation in the stream.	<i>Cinnamomum iners</i> <i>Alocasia macrorrhizos</i> <i>Asystasia gangetica ssp. micrantha</i> <i>Caryota mitis</i> <i>Causonis trifolia</i> <i>Cenchrus purpureus</i> <i>Epipremnum pinnatum</i> <i>Isachne globosa</i> <i>Leea indica</i> <i>Miconia crenata</i> <i>Mikania micrantha</i> <i>Nephrolepis biserrata</i> <i>Paederia foetida</i> <i>Spathodea campanulata</i> <i>Syzygium polyanthum</i>	100	50	No	Some film on surface of water.

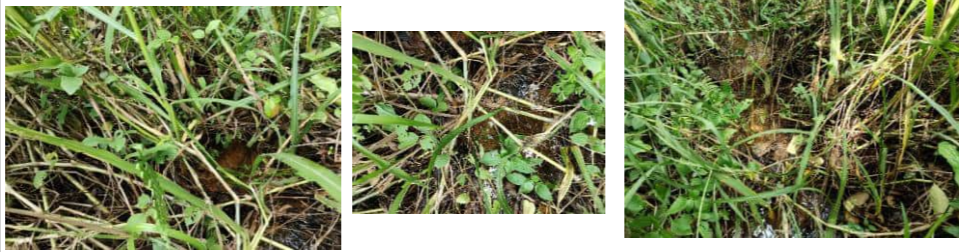
BW6	CS34 (Drawing 3)	103°47'50.81"E	1°20'20.13"N

0.55	10	0.07	Tall grass vegetated soil banks. Bed is covered in dense root network.	Roots	50	No	Clear waters.	
BW7	CS33 (Drawing 3)	103°47'50.85"E	1°20'19.45"N

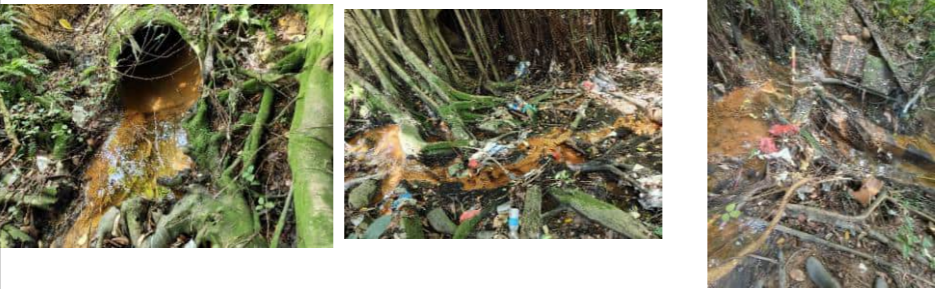
1.65	17	0.02	Root banks. Bed is sandy with large rocks, and is covered in orange moss.	<i>Adiantum latifolium</i> <i>Aphanamixis polystachya</i> <i>Callisia repens</i> <i>Caryota mitis</i> <i>Causonis trifolia</i> <i>Cinnamomum iners</i> <i>Ficus microcarpa</i> <i>Leea indica</i> <i>Nephelium lappaceum</i> <i>Ptychosperma macarthurii</i>		64.7	Low.	Orange flecks observed in water and covering bed. Water is otherwise clear.
BW8	CS32 (Drawing 3)	103°47'50.99"E	1°20'18.80"N

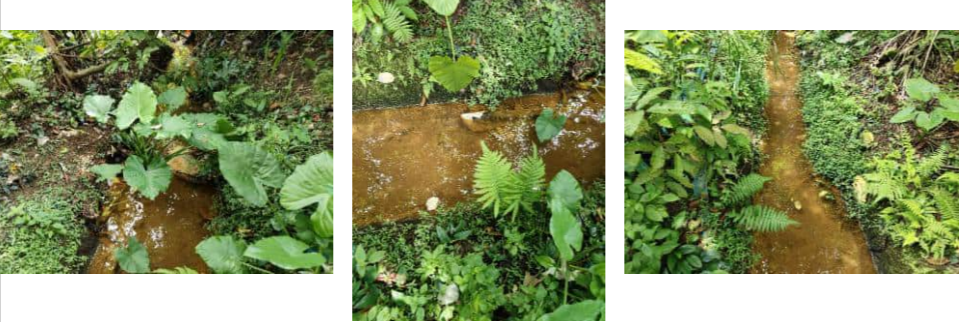
1.00	13	0.08	Concrete banks with sandy-gravelly bed.	<i>Adiantum latifolium</i> <i>Alocasia longiloba</i> <i>Alocasia macrorrhizos</i> <i>Asystasia gangetica ssp. micrantha</i> <i>Callisia repens</i> <i>Caryota mitis</i> <i>Christella dentata</i> <i>Epipremnum aureum</i> <i>Ficus fistulosa</i> <i>Leea indica</i> <i>Momordica charantia</i> <i>Cenchrus purpureus</i> <i>Synedrella nodiflora</i> <i>Syzygium grande</i> <i>Syzygium polyanthum</i>	0-5	55.5	Low	Stringy orange filaments in water, likely caused by iron-utilising bacteria.

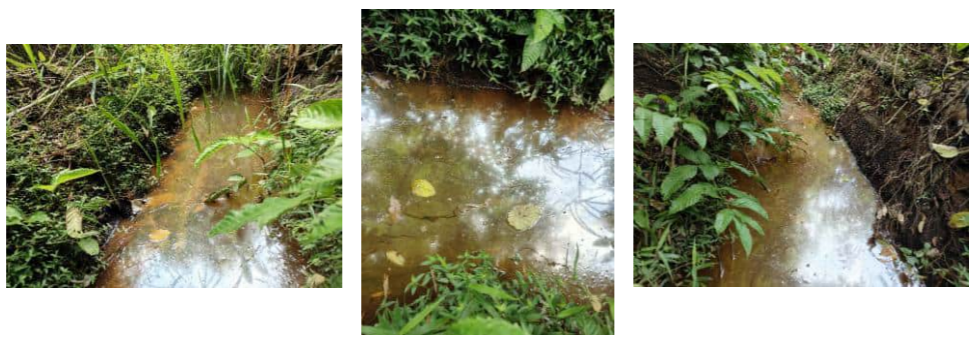
Stream Mapping Point	Cross-section No.	Longitude	Latitude	Photo (In the order of: Upstream, Stream Bed and Downstream)	Channel Wetted Width (m)	Water Depth (cm)	Flow Velocity (Dry Weather) (m/s)	Bed Substrate and Bank Conditions	Riparian Vegetation	Leaf Litter Cover (%)	Canopy Cover (%)	Soil Erosion	Remarks
BW9	CS31 (Drawing 3)	103°47'51.00"E	1°20'18.38"N

0.92	48	Stagnant	Concrete banks with vegetation on top. Concrete bed with small amount of sediment.	<i>Alocasia macrorrhizos</i> <i>Asystasia gangetica ssp. micrantha</i> <i>Callisia repens</i> <i>Leea indica</i> <i>Mikania micrantha</i> <i>Nephrolepis biserrata</i> <i>Cenchrus purpureus</i> <i>Spathodea campanulata</i>	5-10	31.3	No	Film observed on surface of water. Orange filaments observed growing in watercourse. Waters are murky.
BW10	CS30 (Drawing 3)	103°47'51.12"E	1°20'17.83"N

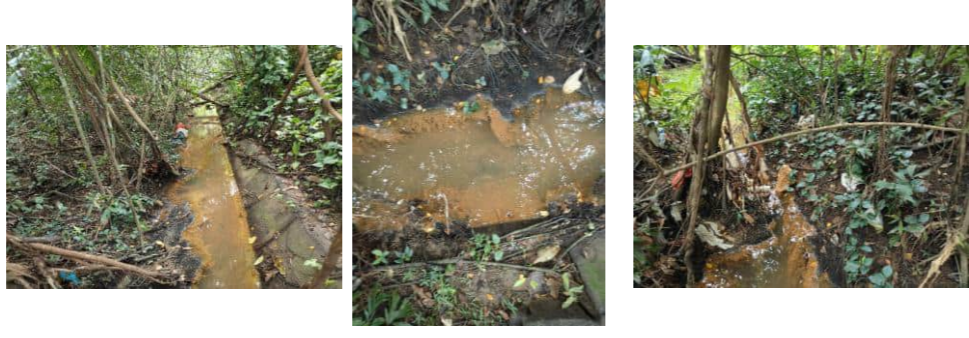
1.02	58	0.03	Concrete banks (R). Concrete banks covered in roots (L). Bed is concrete with a layer of sand.	<i>Alocasia macrorrhizos</i> <i>Aphanamixis polystachya</i> <i>Caryota mitis</i> <i>Cinnamomum iners</i> <i>Ficus microcarpa</i> <i>Leea indica</i> <i>Nephelium lappaceum</i> <i>Piper sarmentosum</i> <i>Syngonium angustatum</i>	0-5	70.5	Low	No remarks.
