Detailed Records of Stream Mapping Turf EIA

Stream Mapping Point No.	Cross-section No.	Longitude	Latitude	Photo (In the order of: Upstream, Stream Bed and Downstream)	Photos of Cross-Section	Cross-section	Channel Wetted Width	Water Depth	Flow Velocity (Dry Weather)	Bed Substrate and Bank Conditions	Riparian Vegetation	Leaf Litter Cover (%)	Canopy Cover (%)	Soil Erosion	Remarks
CW1	-	103.79089	1.34509			Cross-section was not mapped due to its dry condition at the upstream.	Not Applicable	Not Applicable	Not Applicable	Concrete fragments and rocks. Dry earth drain.	Caryota mitis, Fabaceae seedling, Syzygium grande, Caladium sp., Spathodea campanulata, Leea indica, Nephelium lappaceum	5-10%	34.7	No	The starting point of the watercourse within Site E.
CW2	CS12	103.79092	1.34492				0.2 - 0.5 m	5 - 6 cm	Nearly stagnant	Sandy bed, with dead leaves and broken concrete. Earth drain with mild slope, and covered with vegetation.	Acrostichum speciosum, Eleais guineensis, Syzygium grande, Cinnamomum iners, Smilax setosa, Hemigraphis repens, Alsophila laterosa, Ficus heteropleura	50-60%	84.3	Yes	Presence of oil sheen observed. Cloudy brown organic matter observed in the water.

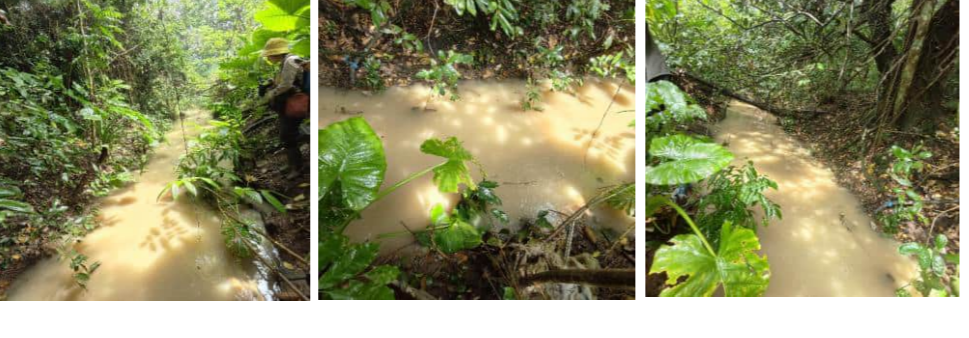
BW11	CS29 (Drawing 3)	103°47'51.13"E	1°20'17.04"N

1.80	37	0.09	Soil banks, sandy bed	<i>Alocasia macrorrhizos</i> <i>Andira inermis</i> <i>Bridelia tomentosa</i> <i>Caryota mitis</i> <i>Cinnamomum iners</i> <i>Claoxylon indicum</i> <i>Ficus punctata</i> <i>Leea indica</i> <i>Syzygium grande</i> <i>Thunbergia fragrans</i> <i>Miconia crenata</i>	20% on surface, unable to see through water.	46.4	Mild	Surface film that is orangey.
BW12	CS28 (Drawing 3)	103°47'51.24"E	1°20'16.29"N

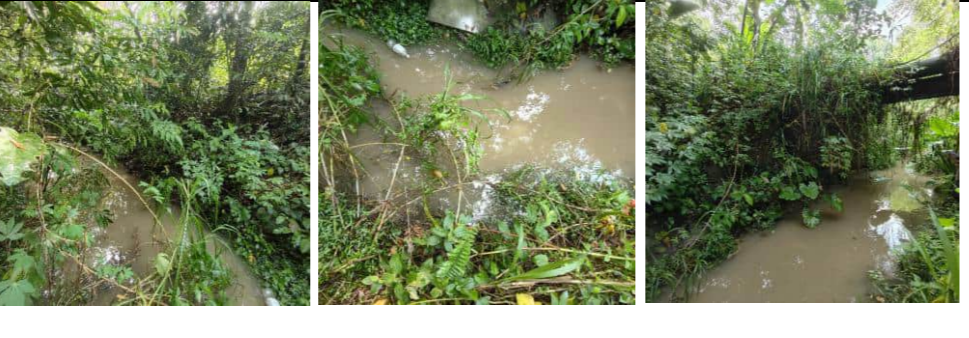
1.65	80	0.03	Sand at bed on top of a concrete base. Concrete banks with vegetated clay soil above the concrete.	<i>Alocasia macrorrhizos</i> <i>Asystasia gangetica ssp. micrantha</i> <i>Callisia repens</i> <i>Ficus fistulosa</i> <i>Manihot esculenta</i> <i>Mikania micrantha</i> <i>Nephrolepis biserrata</i> <i>Cenchrus purpureus</i> <i>Thunbergia fragrans</i> <i>Miconia crenata</i>	Unable to see through water.	20	Mild	Orange filaments at bank. Slightly turbid waters.

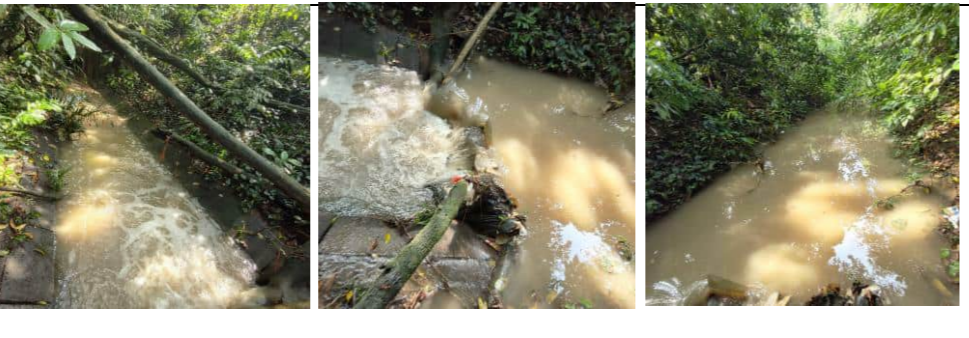
BW13	CS27 (Drawing 3)	103°47'51.14"E	1°20'15.97"N

2.41	43	0.04	Concrete banks and bed.	<i>Adiantum latifolium</i> <i>Alsophila latebrasa</i> <i>Andira inermis</i> <i>Asplenium longissimum</i> <i>Caryota mitis</i> <i>Cinnamomum iners</i> <i>Piper sarmentosum</i> <i>Ptychosperma macarthurii</i> <i>Syzygium grande</i> <i>Syzygium polyanthum</i> <i>Miconia crenata</i> <i>Grypothrix triphylla</i>	Unable to see through water.	51.5	No	Slightly yellow water.

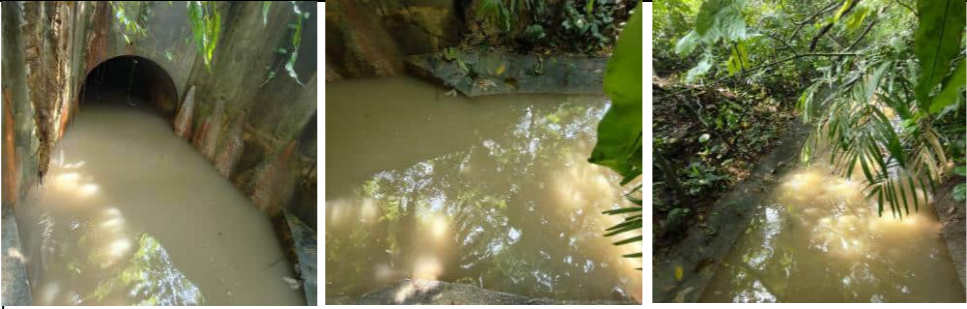
Stream Mapping Point	Cross-section No.	Longitude	Latitude	Photo (In the order of: Upstream, Stream Bed and Downstream)	Channel Wetted Width (m)	Water Depth (cm)	Flow Velocity (Dry Weather) (m/s)	Bed Substrate and Bank Conditions	Riparian Vegetation	Leaf Litter Cover (%)	Canopy Cover (%)	Soil Erosion	Remarks
BW14	CS27 (Drawing 3)	103°47'51.44"E	1°20'15.56"N

1.47	49	Very low flow, almost stagnant.	Concrete banks and bed.	<i>Asplenium nidus var. nidus</i> <i>Baphia nitida</i> <i>Bridelia tomentosa</i> <i>Caryota mitis</i> <i>Cinnamomum iners</i> <i>Claoxylon indicum</i> <i>Dieffenbachia seguine var. seguine</i> <i>Epipremnum aureum</i> <i>Ficus heteropleura</i> <i>Leea indica</i> <i>Ptychosperma macarthurii</i>	Unable to see through water. On water surface, leaf litter is around 10%.	83.6	No	Slightly yellow water.
BW15	Nil, drain.	103°47'52.01"E	1°20'14.32"N

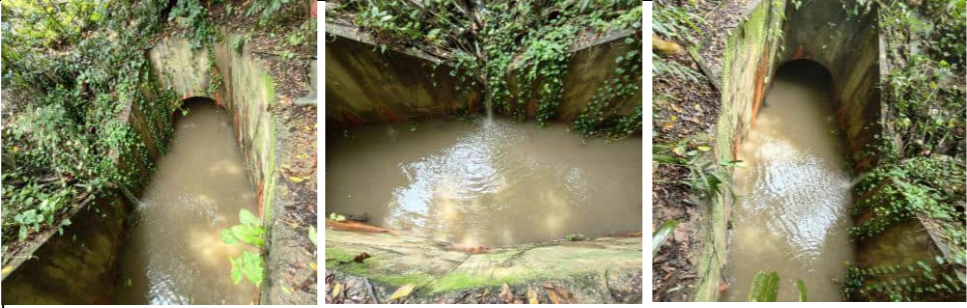
2.71	69	Almost stagnant. Very low flow.	Concrete banks and bed.	<i>Alocasia macrorrhizos</i> <i>Andira inermis</i> <i>Aphanamixis polystachya</i> <i>Baphia nitida</i> <i>Caryota mitis</i> <i>Cinnamomum iners</i> <i>Epipremnum aureum</i> <i>Leea indica</i> <i>Ptychosperma macarthurii</i> <i>Syngonium angustatum</i>	Unable to see through water. On water surface, leaf litter is around 30%.	61.1	No	Turbid waters. Leaf litter and foam on surface of water. Orange stains on the banks, indicating presence of iron-utilising bacteria.

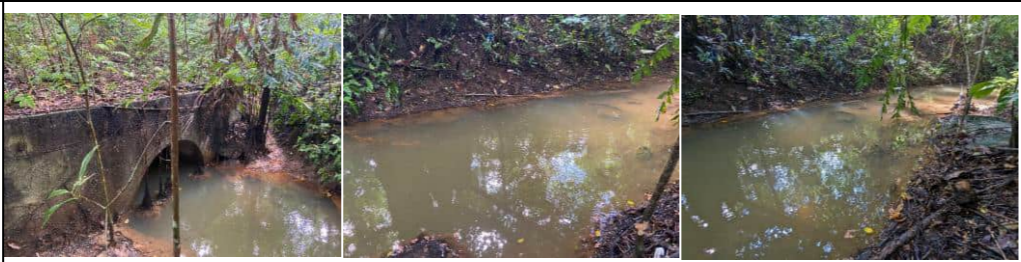
BW16	Nil, drain.	103°47'52.51"E	1°20'13.60"N	 	2.41	62	Stagnant	Concrete banks and bed.	<i>Andira inermis</i> <i>Baphia nitida</i> <i>Caryota mitis</i> <i>Cinnamomum iners</i> <i>Dioscorea sansibarensis</i> <i>Epipremnum aureum</i> <i>Ptychosperma macarthurii</i> <i>Syzygium grande</i>	Unable to see through water. On water surface, leaf litter is around 20-25%.	18.4	No	Surface film observed, with bubbles on water surface.
BW17	CS26 (Drawing 3)	103°47'53.12"E	1°20'13.05"N

3.06	61	Almost stagnant.	Clay like soil banks and bed.	<i>Adiantum latifolium</i> <i>Alocasia macrorrhizos</i> <i>Caryota mitis</i> <i>Elaeis guineensis</i> <i>Stenochlaena palustris</i> <i>Callisia repens</i> <i>Alsophila latebrosa</i> <i>Andira inermis</i> <i>Cinnamomum iners</i> <i>Artocarpus heterophyllus</i> <i>Ficus fistulosa</i> <i>Syzygium grande</i> <i>Syzygium myrtifolium</i> <i>Leea indica</i>	Unable to see through water.	50	Medium	No remarks.

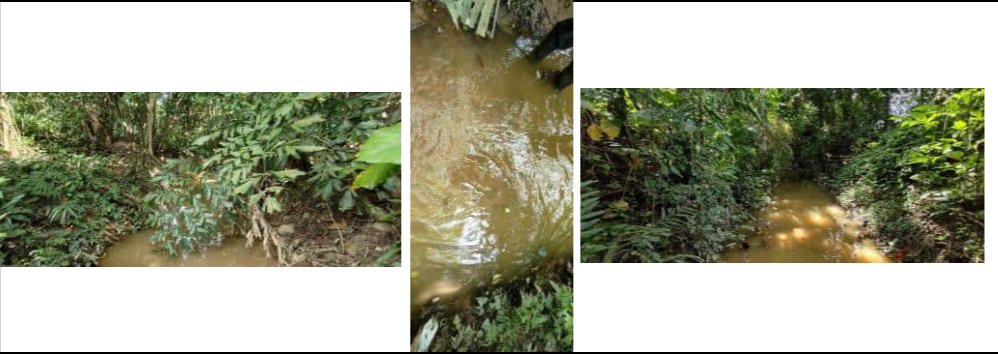
2.54	7 - 16	0.14	Vegetated clay banks and sandy bed.	<i>Alocasia macrorrhizos</i> <i>Caryota mitis</i> <i>Piper sarmentosum</i> <i>Ptychosperma macarthurii</i> <i>Spathodea campanulata</i> <i>Adiantum latifolium</i> <i>Dimocarpus longan</i> <i>Ficus fistulosa</i> <i>Leea indica</i> <i>Piper betle</i> <i>Tectaria incisa</i> <i>Syngonium angustatum</i> <i>Syzygium grande</i>	5-10	70	Mild (R) High (L)	No remarks.
EW6	CS5 (Drawing 2)	103°47'49.25"E	1°20'6.48"N

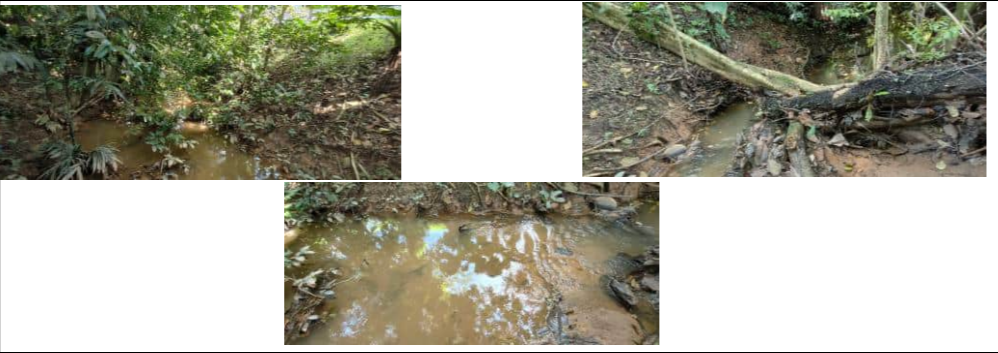
2.91	12	0.13	Clay sand bed. Clay bank on left, vegetated clay bank on right.	<i>Alocasia macrorrhizos</i> <i>Cinnamomum iners</i> <i>Ptychosperma macarthurii</i> <i>Spathodea campanulata</i> <i>Baphia nitida</i> <i>Clausena excavata</i> <i>Ficus fistulosa</i> <i>Syngonium angustatum</i> <i>Tectaria incisa</i> <i>Terminalia catappa</i> <i>Syzygium polyanthum</i>	15	85	High (L) Low (R)	Relatively clear water

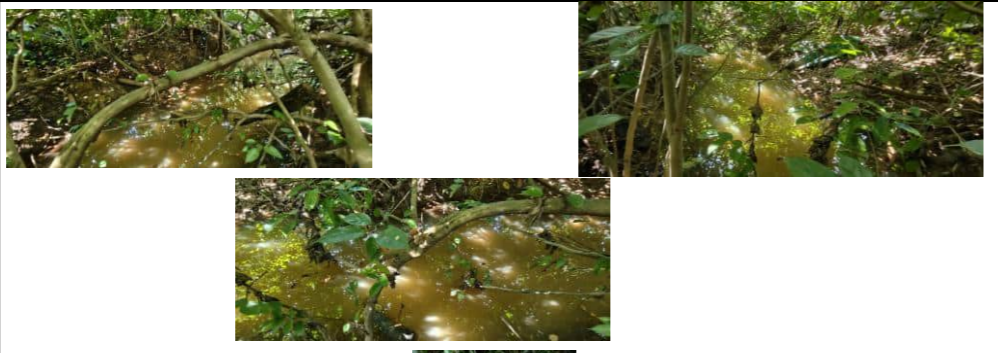
EW7	CS4 (Drawing 2)	103°47'49.63"E	1°20'6.00"N

3.15	47	Almost stagnant; very low flow	Sandy clay root banks. Sandy bed.	<i>Spathodea campanulata</i> <i>Baphia nitida</i> <i>Pterocarpus indicus</i>	Unable to see through water.	100	High	Turbid waters.
EW8	CS3 (Drawing 2)	103°47'50.16"E	1°20'5.27"N

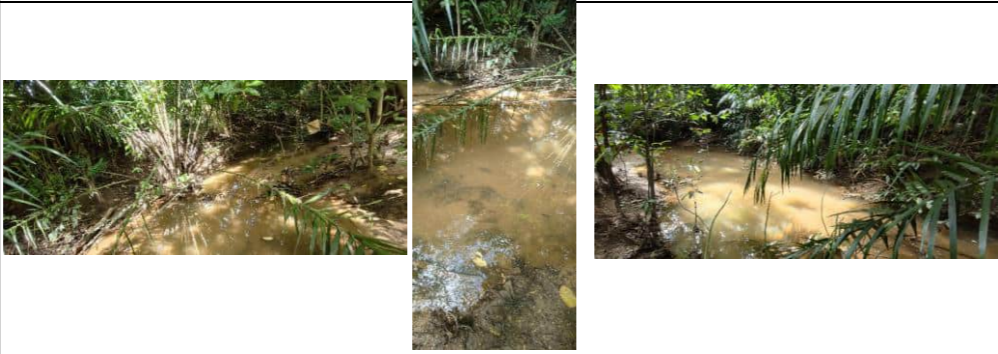
4.33	10 - 16	0.15	Sandy bed. Soil clay banks that are slightly vegetated.	<i>Baphia nitida</i> <i>Cinnamomum iners</i> <i>Piper sarmentosum</i> <i>Syngonium angustatum</i> <i>Caryota mitis</i> <i>Dimocarpus longan</i> <i>Elaeis guineensis</i> <i>Syzygium polyanthum</i>	15	40	No (L) Mild (R)	Relatively clear water. Some leaf litter accumulating on surface.
EW9	CS3 (Drawing 2)	103°47'50.64"E	1°20'5.05"N

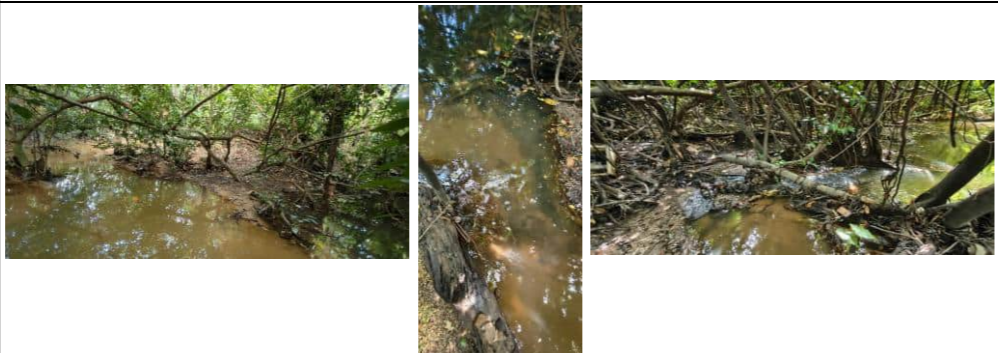
2.24	11 - 16	0.12	Sandy bed. Vegetated sandy banks.	<i>Baphia nitida</i> <i>Ficus microcarpa</i> <i>Syngonium angustatum</i>	0-5	80	No	Relatively clear water. Trees are also growing in the middle of the stream.

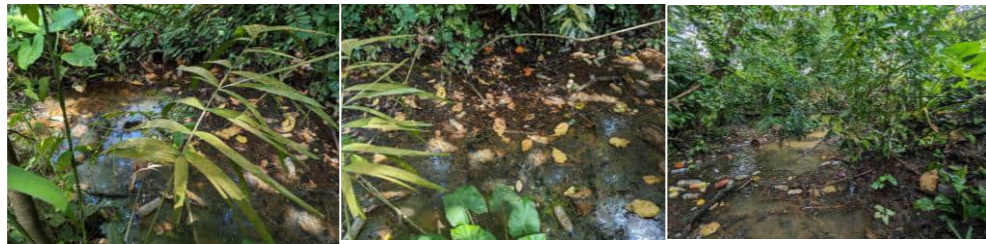
Stream Mapping Point	Cross-section No.	Longitude	Latitude	Photo (In the order of: Upstream, Stream Bed and Downstream)	Channel Wetted Width (m)	Water Depth (cm)	Flow Velocity (Dry Weather) (m/s)	Bed Substrate and Bank Conditions	Riparian Vegetation	Leaf Litter Cover (%)	Canopy Cover (%)	Soil Erosion	Remarks
<b>D12-B Tributary</b>													
EW10	CS17 (Drawing 2)	103°47'49.06"E	1°20'9.45"N

3.00	33 - 66	Stagnant	Vegetated earth banks.	<i>Alocasia macrorrhizos</i> <i>Aphanamixis polystachya</i> <i>Caryota mitis</i> <i>Cinnamomum iners</i> <i>Dracaena fragrans</i> <i>Epipremnum pinnatum</i> <i>Isachne globosa</i> <i>Mikania micrantha</i> <i>Piper betle</i> <i>Spathodea campanulata</i> <i>Tetracera indica</i> <i>Thunbergia fragrans</i> <i>Syngonium angustatum</i>	Unable to see through water.	71.3	Mild	Some rubbish and leaf litter floating on surface of water. Waters have surface film. Water has odour.

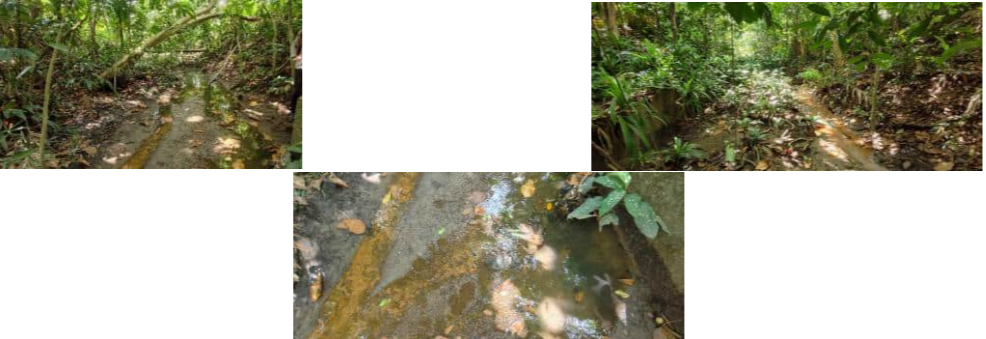
EW11	CS16 (Drawing 2)	103°47'49.40"E	1°20'8.98"N

0.72	1	0.22	Sandy gravel bed. Beginning of concrete banks on left, while right bank remains as vegetated sand banks.	<i>Andira inermis</i> <i>Caryota mitis</i> <i>Cinnamomum iners</i> <i>Dieffenbachia seguine var. seguine</i> <i>Ficus fistulosa</i> <i>Ficus heteropleura</i> <i>Piper betle</i> <i>Ptychosperma macarthurii</i> <i>Terminalia catappa</i> <i>Tinospora crispa</i> <i>Syngonium angustatum</i>	10 - 20	89	No	Yellow specks observed in water, indicating iron-utilising bacteria presence.
EW12	CS16 (Drawing 2)	103°47'49.63"E	1°20'8.60"N	 	1.08	3	Stagnant	Vegetated soil clay and sand banks. And bed.	<i>Alocasia macrorrhizos</i> <i>Andira inermis</i> <i>Caryota mitis</i> <i>Cinnamomum iners</i> <i>Dieffenbachia seguine var. seguine</i> <i>Pandanus amaryllifolius</i> <i>Piper betle</i> <i>Ptychosperma macarthurii</i> <i>Syzygium polyanthum</i> <i>Terminalia catappa</i> <i>Syngonium angustatum</i>	10 - 20	78.6	High (L) No (R)	Surface film on water observed.

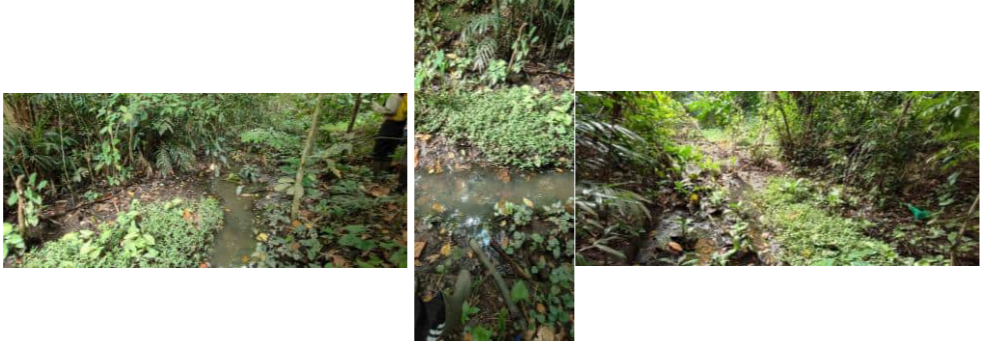
EW13	CS15 (Drawing 2)	103°47'49.96"E	1°20'7.97"N

0.95	21	Almost stagnant. Very low flow.	Concrete bank (L), grassy soil bank on right bank. Red clay and sand bed.	<i>Andira inermis</i> <i>Caryota mitis</i> <i>Cinnamomum iners</i> <i>Dieffenbachia seguine var. seguine</i> <i>Ptychosperma macarthurii</i> <i>Syzygium myrtifolium</i> <i>Syzygium polyanthum</i> <i>Syngonium angustatum</i>	30-40	79.6	No	Slightly yellow water.
EW14	CS14 (Drawing 2)	103°47'50.18"E	1°20'7.38"N	 	2.5	40	Stagnant	Leaf litter on top of clay bed. Grassy soil banks.	<i>Andira inermis</i> <i>Caryota mitis</i> <i>Cenchrus purpureus</i> <i>Dieffenbachia seguine var. seguine</i> <i>Ficus fistulosa</i> <i>Lea indica</i> <i>Callisia repens</i> <i>Syngonium angustatum</i> <i>Syzygium polyanthum</i>	100	95	No	Turbid waters.

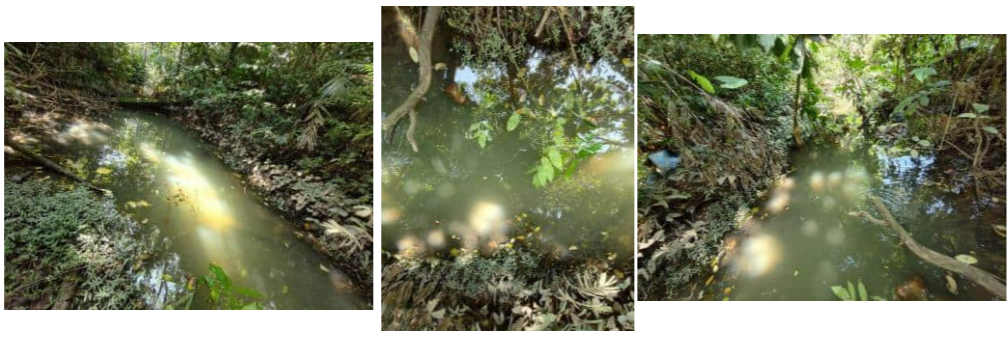
Stream Mapping Point	Cross-section No.	Longitude	Latitude	Photo (In the order of: Upstream, Stream Bed and Downstream)	Channel Wetted Width (m)	Water Depth (cm)	Flow Velocity (Dry Weather) (m/s)	Bed Substrate and Bank Conditions	Riparian Vegetation	Leaf Litter Cover (%)	Canopy Cover (%)	Soil Erosion	Remarks
EW15	CS13 (Drawing 2)	103°47'50.56"E	1°20'6.65"N

4.60	64	0.02	Sandy egetates root banks with sandy bed. Trees are observed growing in the watercourse.	<i>Callisia repens</i> <i>Caryota mitis</i> <i>Causonis trifolia</i> <i>Cinnamomum iners</i> <i>Clausena excavata</i> <i>Hydrilla verticillata</i> <i>Leea indica</i> <i>Ptychosperma macarthurii</i> <i>Syzygium polyanthum</i> <i>Terminalia catappa</i> <i>Syngonium angustatum</i>	5-10	71	No	No remarks.
EW16	CS12 (Drawing 2)	103°47'50.44"E	1°20'5.97"N

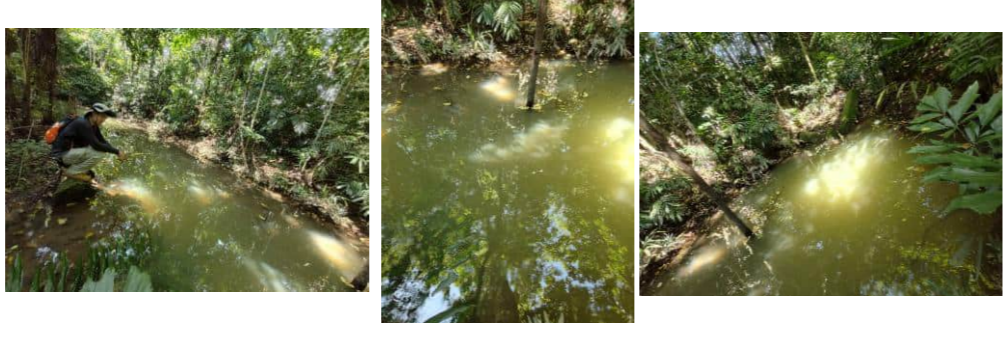
4.60	64	0.02	Sandy egetates root banks with sandy bed. Trees are observed growing in the watercourse.	<i>Alocasia macrorrhizos</i> <i>Adenanthera pavonina</i> <i>Callisia repens</i> <i>Caryota mitis</i> <i>Dieffenbachia seguine var. seguine</i> <i>Syngonium angustatum</i> <i>Syzygium polyanthum</i> <i>Aphanamixis polystachya</i> <i>Cinnamomum iners</i>	5-10	71	No	No remarks.

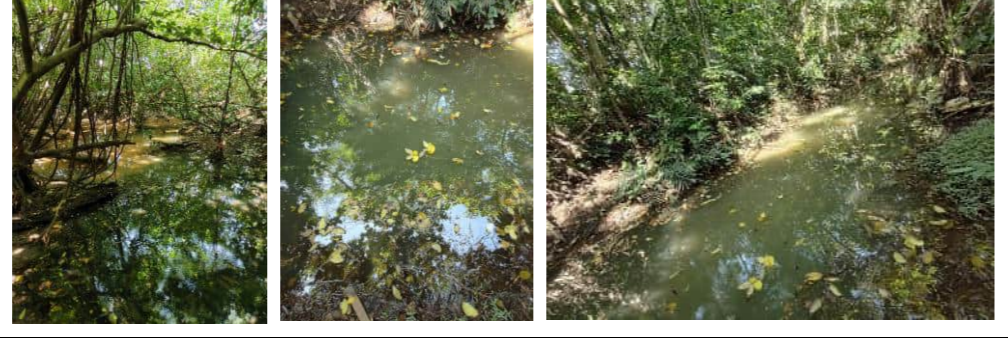
EW17	CS11 (Drawing 2)	103°47'50.60"E	1°20'5.73"N

4.60	64	0.02	Sandy egetates root banks with sandy bed. Trees are observed growing in the watercourse.	<i>Baphia nitida</i> <i>Ficus microcarpa</i> <i>Ptychosperma macarthurii</i> <i>Spathodea campanulata</i>	5-10	71	No	No remarks.
EW18	CS2 (Drawing 2)	103°47'50.88"E	1°20'4.82"N

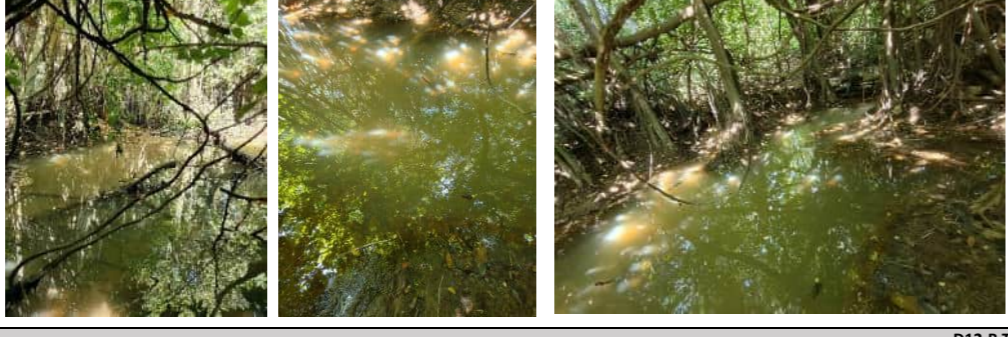
4.60	64	0.02	Sandy egetates root banks with sandy bed. Trees are observed growing in the watercourse.	<i>Baphia nitida</i> <i>Ficus microcarpa</i>	5-10	71	No	No remarks.
<b>D12-B Tributary End</b>													
<b>D12</b>													
EW19	CS1 (Drawing 2)	103°47'51.08"E	1°20'4.43"N

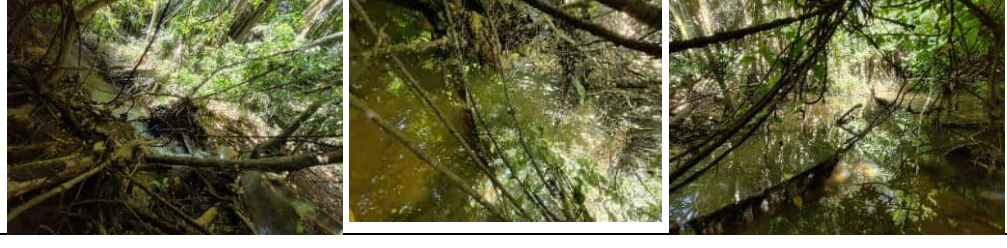
4.22	55	0.03	Sandy bed with vegetated sandy banks. Trees are also growing in the watercourse and root clumps observed in water.	<i>Baphia nitida</i> <i>Christella dentata</i> <i>Ptychosperma macarthurii</i>	10-20	76.8	No (L) Mild (R)	No remarks.

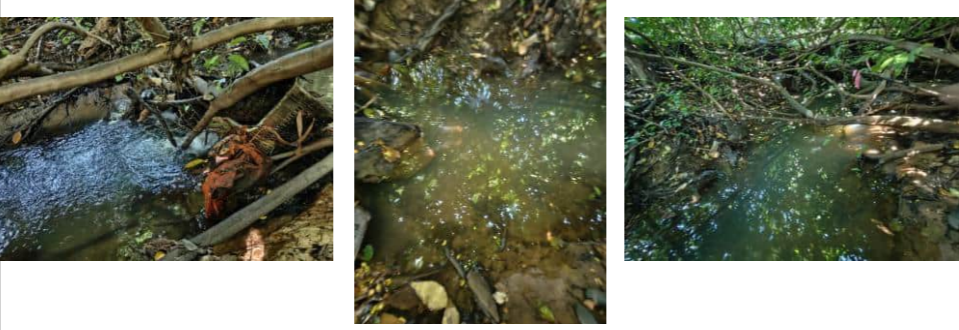
Stream Mapping Point	Cross-section No.	Longitude	Latitude	Photo (In the order of: Upstream, Stream Bed and Downstream)	Channel Wetted Width (m)	Water Depth (cm)	Flow Velocity (Dry Weather) (m/s)	Bed Substrate and Bank Conditions	Riparian Vegetation	Leaf Litter Cover (%)	Canopy Cover (%)	Soil Erosion	Remarks
EW20	Nil, drain.	103°47'51.29"E	1°20'3.55"N

2.99	53	0.06	Sandy banks with some vegetation on the right bank and sandy bed. Log and rubbish causing blockage in watercourse.	<i>Baphia nitida</i> <i>Bridelia tomentosa</i>	0-5	70.2	Mild	No remarks.
EW21	Nil, drain.	103°47'51.51"E	1°20'2.89"N

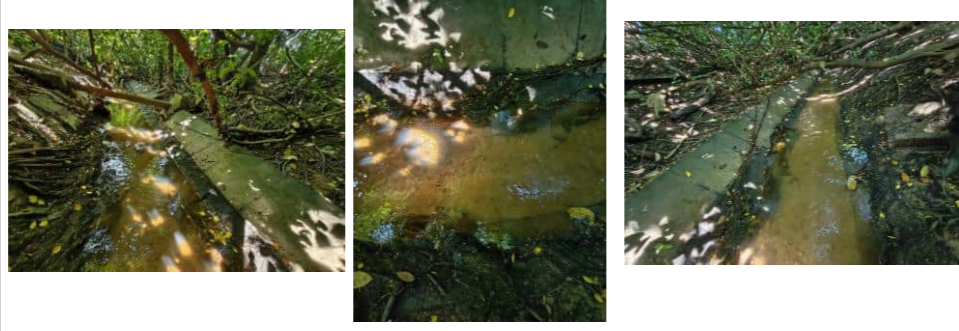
1.15	17	0.25	Sandy bed. Sandy root bank on left and concrete bank right.	<i>Baphia nitida</i> <i>Ficus fistulosa</i> <i>Ptychosperma macarthurii</i> <i>Aphanamixis polystachya</i>	0-5	70.2	No	No remarks.
EW22	Nil, drain.	103°47'51.92"E	1°20'2.43"N

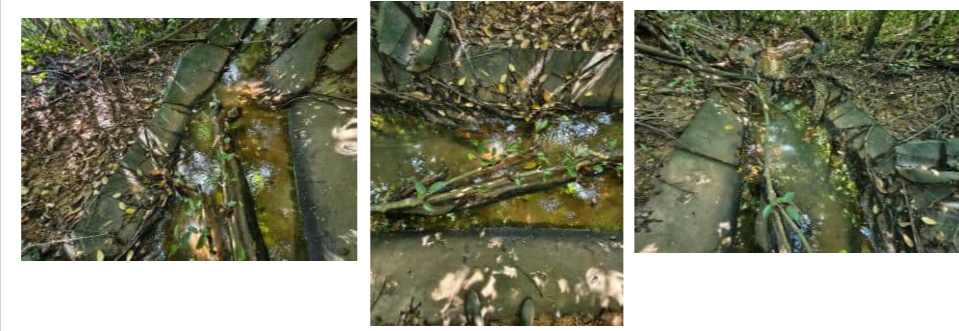
1.35	37	0.13	Concrete banks. Bed is sandy with small rocks. Watercourse is partly blocked with log.	<i>Baphia nitida</i>	0-5	85.8	No	Water is slightly cloudy.

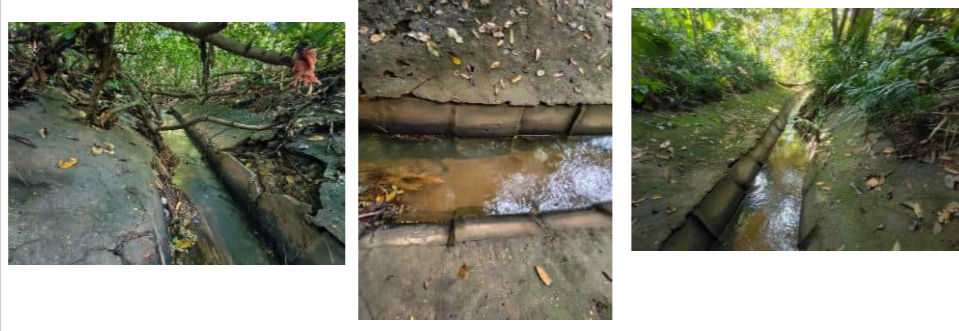
EW23	Nil, drain.	103°47'52.08"E	1°20'1.88"N

0.81	32	0.33	Concrete banks, concrete bed with a layer of sand. Root clumps are also observed in the watercourse.	<i>Cinnamomum iners</i> <i>Ficus religiosa</i> <i>Ptychosperma macarthurii</i> <i>Syzygium myrtifolium</i> <i>Aphanamixis polystachya</i>	0-5	86.6	No	No remarks.
EW24	Nil, drain.	103°47'52.25"E	1°20'1.20"N

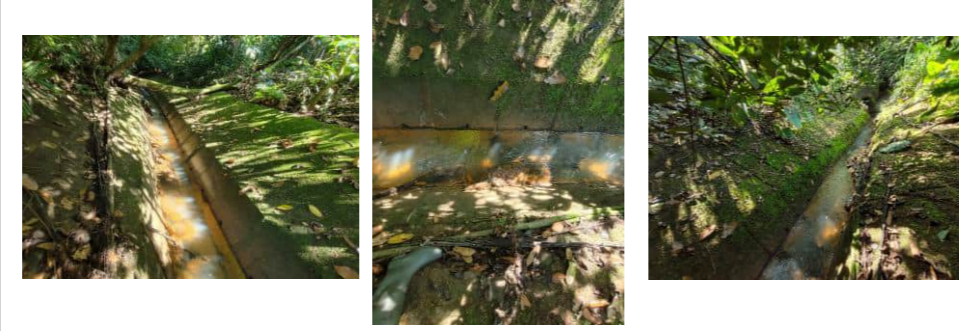
0.65	28	0.40	Concrete banks and bed. Banks are covered in moss. Root clumps are also observed in the watercourse.	<i>Alocasia macrorrhizos</i> <i>Cinnamomum iners</i> <i>Peltophorum pterocarpum</i> <i>Spathodea campanulata</i> <i>Syzygium polyanthum</i> <i>Centotheca lappacea</i>	0-5	37.5	No	No remarks.

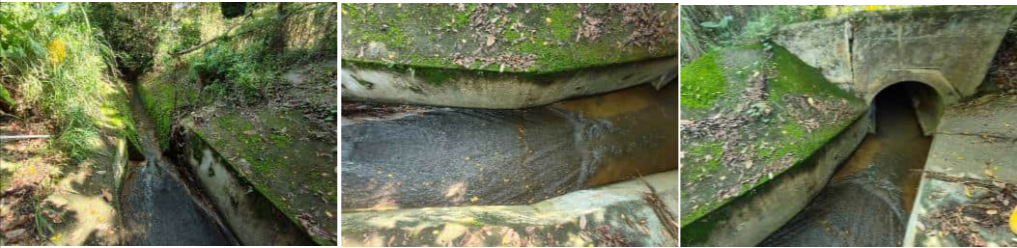
Stream Mapping Point	Cross-section No.	Longitude	Latitude	Photo (In the order of: Upstream, Stream Bed and Downstream)	Channel Wetted Width (m)	Water Depth (cm)	Flow Velocity (Dry Weather) (m/s)	Bed Substrate and Bank Conditions	Riparian Vegetation	Leaf Litter Cover (%)	Canopy Cover (%)	Soil Erosion	Remarks
EW25	Nil, drain.	103°47'52.21"E	1°20'0.77"N

1.50	4	0.67	Concrete banks and bed.	<i>Alocasia macrorrhizos</i> <i>Bridelia tomentosa</i> <i>Cenchrus purpureus</i> <i>Ficus fistulosa</i>	0-5	85.9	No	No remarks.
D12 End D7 (after Site B)													
EW26	CS18 (Drawing 2)	103°47'50.74"E	1°20'7.30"N

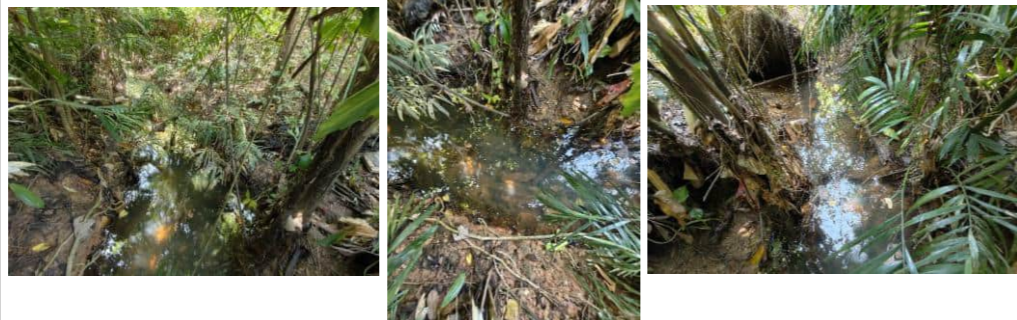
1.77	39	0.03	Vegetated soil banks. Bed is covered in leaf litter.	<i>Alocasia macrorrhizos</i> <i>Andira inermis</i> <i>Aphanamixis polystachya</i> <i>Callisia repens</i> <i>Caryota mitis</i> <i>Causonis trifolia</i> <i>Claoxyton indicum</i> <i>Leea indica</i> <i>Paederia foetida</i> <i>Syzygium polyanthum</i> <i>Syngonium angustatum</i>	100	82.7	High (R) Medium (L)	Clear water with small fishes observed.

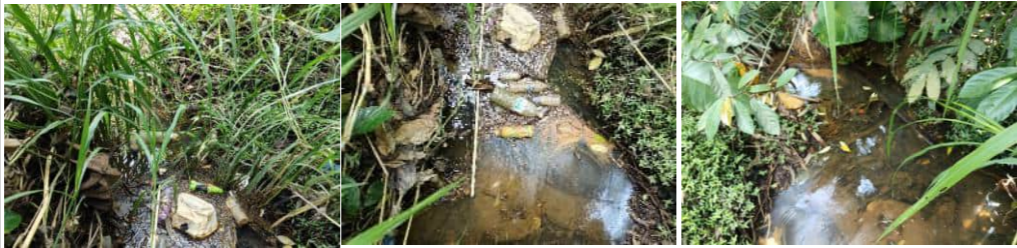
EW27	CS19 (Drawing 2)	103°47'51.04"E	1°20'7.81"N

1.21	36	0.15	Vegetated sandy banks. Gravelly sandy bed with roots.	<i>Caryota mitis</i> <i>Cinnamomum iners</i> <i>Ptychosperma macarthurii</i> <i>Syzygium grande</i> <i>Syzygium polyanthum</i> <i>Terminalia catappa</i> <i>Syngonium angustatum</i>	90	61.6	Medium (R) High (L)	Clear water.
EW28	CS20 (Drawing 2)	103°47'51.55"E	1°20'8.32"N

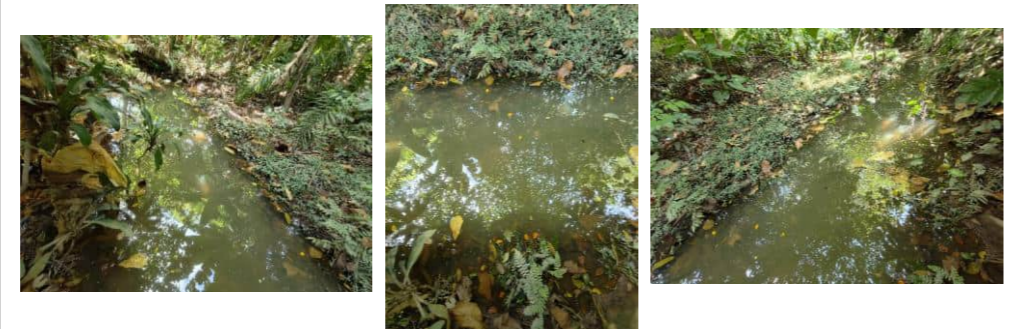
1.35	27	0.03	Vegetated soil bank (L). Soil bank (R). Sandy bed with leaf litter.	<i>Alocasia macrorrhizos</i> <i>Aphanamixis polystachya</i> <i>Callisia repens</i> <i>Ficus fistulosa</i> <i>Mikania micrantha</i> <i>Paederia foetida</i> <i>Cenchrus purpureus</i>	100	65.2	Overhang (L) High (R)	Clear water. Rubbish and small fishes observed. Surface film observed.
EW29	CS21 (Drawing 3)	103°47'51.76"E	1°20'8.76"N

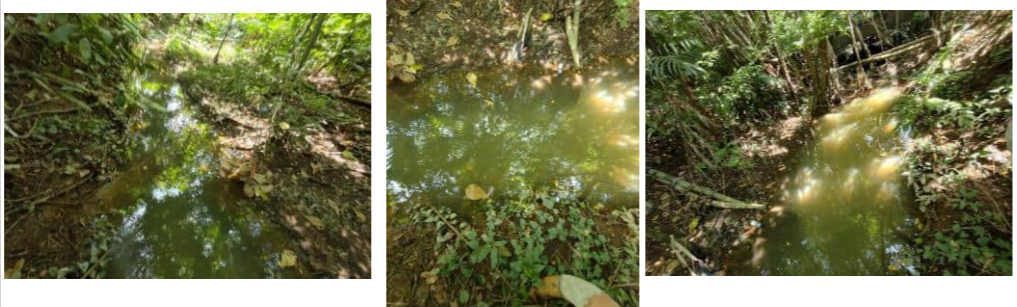
2.25	38	0.02	Grassy soil banks on right. Grassy and vegetated soil banks on left. Bed is covered in leaf litter.	<i>Alocasia macrorrhizos</i> <i>Andira inermis</i> <i>Callisia repens</i> <i>Cinnamomum iners</i> <i>Dracaena fragrans</i> <i>Leea indica</i> <i>Mikania micrantha</i> <i>Ptychosperma macarthurii</i> <i>Terminalia catappa</i> <i>Syngonium angustatum</i>	90-100	50.6	Low	Slightly turbid waters.

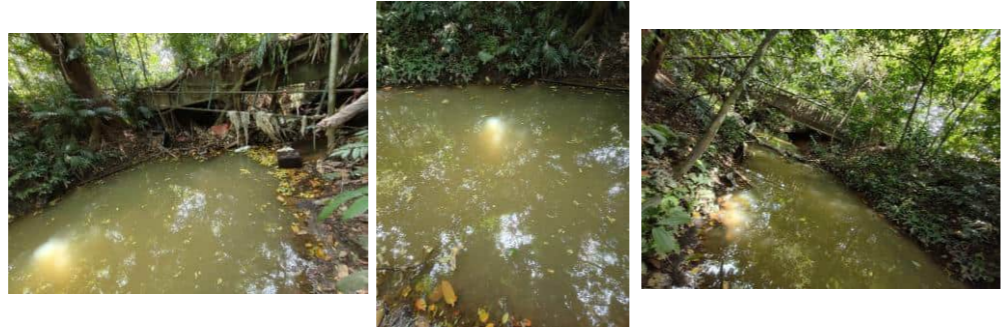
Stream Mapping Point	Cross-section No.	Longitude	Latitude	Photo (In the order of: Upstream, Stream Bed and Downstream)	Channel Wetted Width (m)	Water Depth (cm)	Flow Velocity (Dry Weather) (m/s)	Bed Substrate and Bank Conditions	Riparian Vegetation	Leaf Litter Cover (%)	Canopy Cover (%)	Soil Erosion	Remarks
EW30	CS22 (Drawing 3)	103°47'52.05"E	1°20'9.46"N

2.00	49	0.02	Soil banks on right. Vegetated soil banks on left. Bed is covered with leaf litter and roots.	<i>Adiantum latifolium</i> <i>Andira inermis</i> <i>Aphanamixis polystachya</i> <i>Callisia repens</i> <i>Caryota mitis</i> <i>Cinnamomum iners</i> <i>Epipremnum aureum</i>	90-100	80	No (R) Medium L	Turbid waters.
EW31	CS23 (Drawing 3)	103°47'52.36"E	1°20'10.21"N

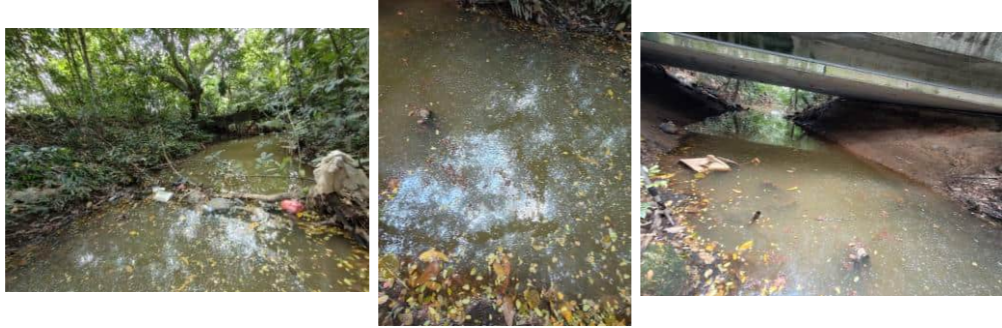
5.00	103	Very low	Vegetated soil banks. Unable to assess the bed conditions due to very turbid waters.	<i>Adenanthera pavonina</i> <i>Adiantum latifolium</i> <i>Alsophila latebrosa</i> <i>Andira inermis</i> <i>Aphanamixis polystachya</i> <i>Arthropodium jackianum</i> <i>Caryota mitis</i> <i>Dimocarpus longan</i> <i>Ptychosperma macarthurii</i> <i>Syzygium grande</i> <i>Grypothrix triphylla</i>	Unable to assess due to turbid waters.	46	Low	Turbid waters with rubbish downstream.

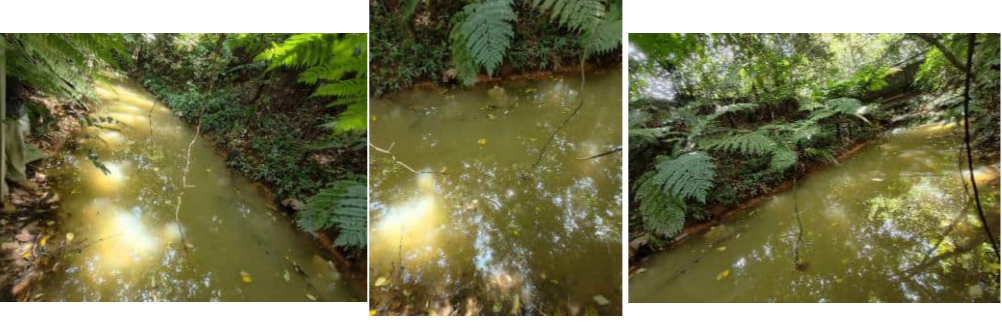
EW32	CS23 (Drawing 3)	103°47'52.34"E	1°20'10.54"N

4.47	56	Very low, almost stagnant.	Vegetated soil banks with a mix of litter and leaf litter bed.	<i>Adenanthera pavonina</i> <i>Adiantum latifolium</i> <i>Andira inermis</i> <i>Caryota mitis</i> <i>Cinnamomum iners</i> <i>Claoxylon indicum</i> <i>Epipremnum aureum</i> <i>Ficus fistulosa</i> <i>Ptychosperma macarthurii</i> <i>Syzygium polyanthum</i>	Estimated 50% from surface of water.	42.7	Low	Surface film with lots of bubbles on surface of water.
EW33	CS24 (Drawing 3)	103°47'52.70"E	1°20'11.27"N

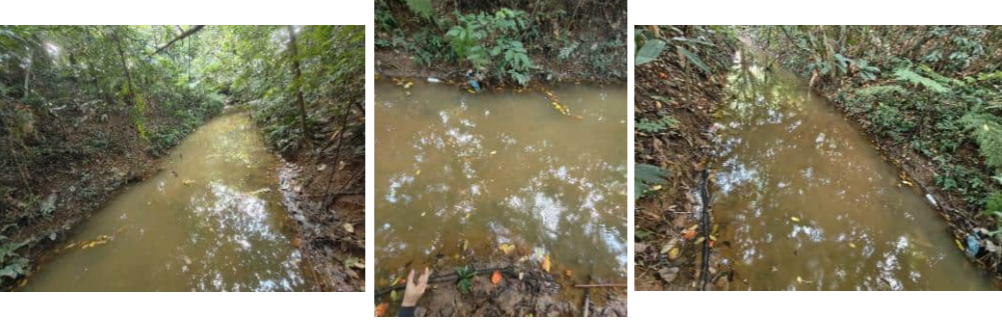
4.40	98	Stagnant	Vegetated soil and clay banks. Sandy and gravelly bed.	<i>Adiantum latifolium</i> <i>Alsophila latebrosa</i> <i>Andira inermis</i> <i>Aphanamixis polystachya</i> <i>Caryota mitis</i> <i>Leea indica</i> <i>Stenochlaena palustris</i> <i>Syzygium cerasiforme</i> <i>Taenitis blechnoides</i> <i>Grypothrix triphylla</i>	30	66.3	Medium	Film observed on surface. Waters are turbid.

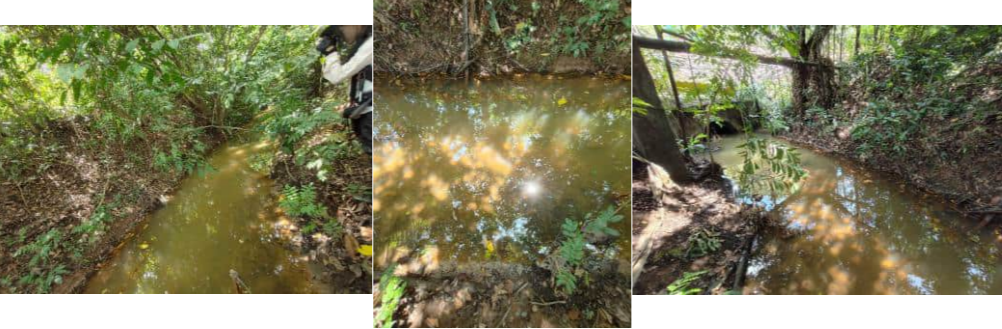
EW34	CS25 (Drawing 3)	103°47'52.851"E	1°20'11.827"N

3.00	31	Very low, almost stagnant (~0.01 m/s)	Vegetated sandy-clay banks with sandy bed. Leaf litter in middle of stream.	<i>Adenanthera pavonina</i> <i>Adiantum latifolium</i> <i>Alsophila latebrosa</i> <i>Andira inermis</i> <i>Cinnamomum iners</i> <i>Ficus fistulosa</i> <i>Leea indica</i> <i>Nephelium lappaceum</i> <i>Stenochlaena palustris</i> <i>Syzygium polyanthum</i> <i>Miconia crenata</i> <i>Grypothrix triphylla</i>	15-20	83.8	High	Very turbid waters.
