URGENT FIELD SAFETY NOTICE

Product Name: **Alaris™ GS, GH, CC, TIVA, PK, Enteral Syringe Pump**

Product Name: **Asena™ GS, GH, CC, TIVA, PK Syringe Pumps**

09 May 2017

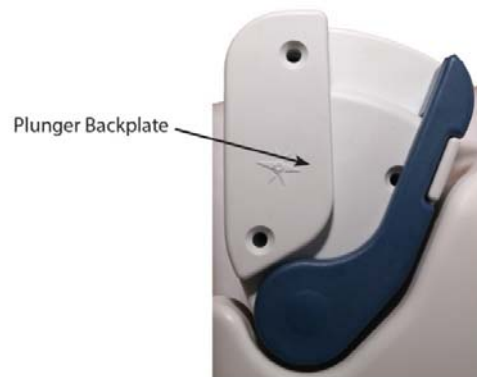
3. Remove three screws holding plunger backplate.

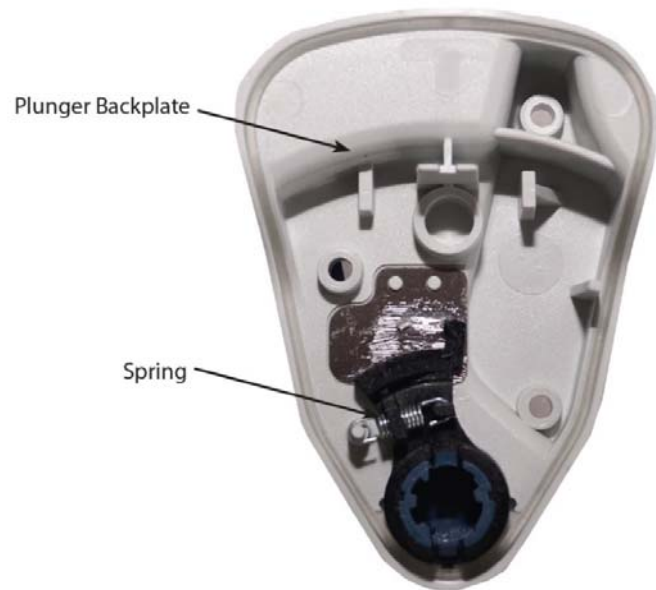
4. Remove the spring from the plunger backplate.
5. Fit a new spring to the plunger backplate.
6. Refit the plunger backplate.
7. Fit the three screws into the plunger backplate.
