To our customers of  
Dräger Infinity ACS Workstation Critical Care (Evita Infinity V500)  
Dräger Infinity ACS Workstation Neonatal Care (Babylog VN500) and  
Dräger Evita V300  
using optional Power Supply Unit PS500

## **Important Safety Notice!!!**

### **Optional Power Supply Unit PS500 used in connection with Evita Infinity V500, Babylog VN500 or Evita V300 Battery capacity will not last as long as expected**

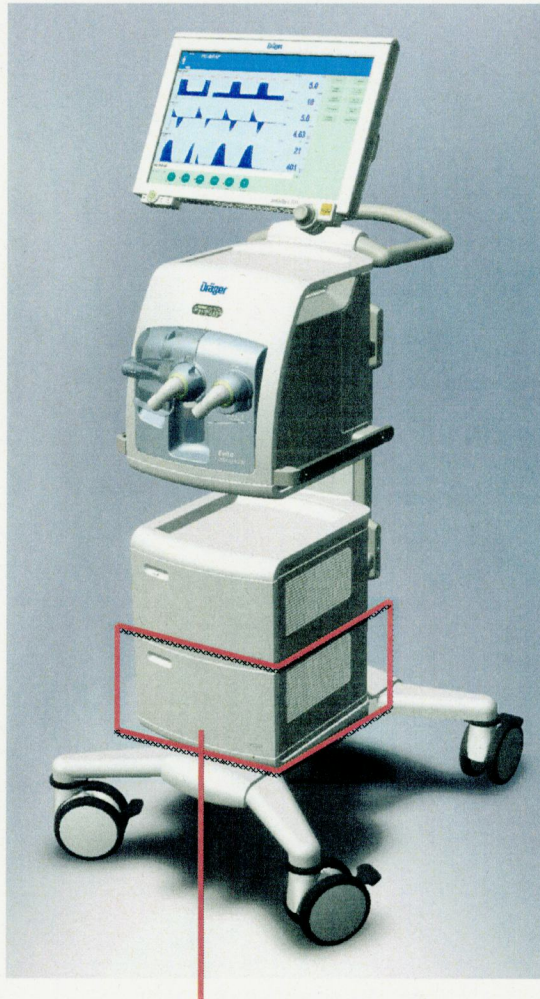
Appendix:  
Picture illustrating optional PS500

optional PS500 - Power supply unit
