To all end-users of  
NIHON KOHDEN Central Monitors CNS-6201 series

**Subject: IMPORTANT FIELD SAFETY NOTICE (FSN)****Information about a Field Safety Corrective Action (FSCA) for NIHON KOHDEN  
Central Monitors model CNS-6201,  
Graphic board VBIOS settings  
[Referenznummer: CNS-6201/2015/1]**

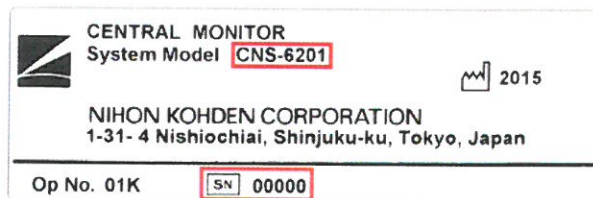
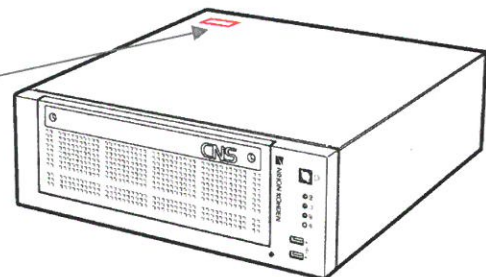
Note: You can find the model name and serial number of the Central Monitor CNS-6201 on the name plate of the device on top of the housing.
